Journal article, Published version

Seismic Assessment of a Modernist Building in Sarajevo, Bosnia and Herzegovina

Keywords: confined masonry; modernist architecture; seismic analysis; 3Muri; pushover analysis

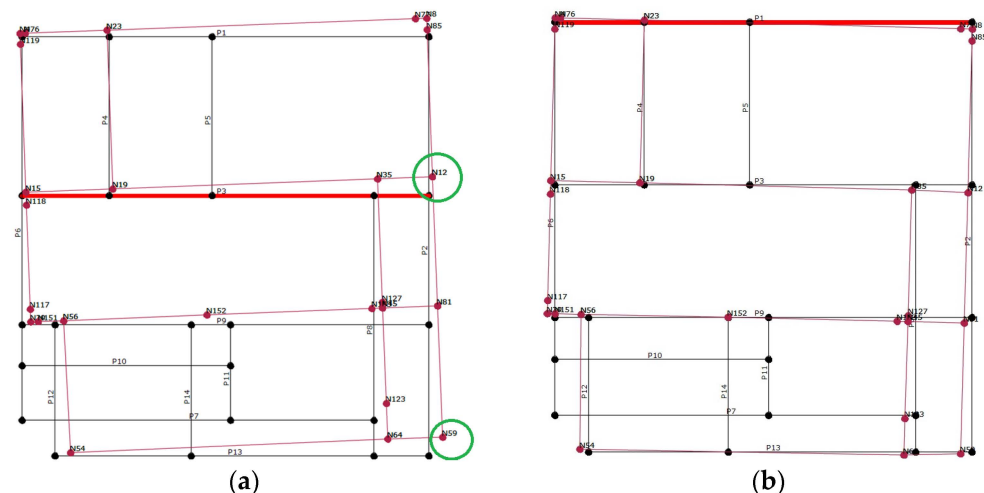
Figure 10. Eigen modes. (a) First eigen mode, Y-direction; (b) second eigen mode, X-direction.

It is interesting to note that both modes are not purely translational; there is also some rotational motion, as evident in Figure 10. Torsional modes can occur in masonry structures, especially when there are asymmetries or irregularities in the distribution of mass and stiffness. The torsion is primarily attributed to the asymmetric positioning of the load-bearing walls, which results in uneven distribution of forces throughout the structure. Additionally, the presence of the four columns introduces structural irregularities, further exacerbating torsional effects. Moreover, the inclusion of confining elements, such as tie-columns and “reinforcement walls,” contributes to the complex interplay of forces within the structure, ultimately leading to a discrepancy between the center of mass and the center of stiffness. These discrepancies amplified torsional forces, making it a significant factor in the structural behavior of the system.
