Source / Izvornik: **Tehnički vjesnik, 2010, 17, 209 - 215**

TESTING OF PHYSICAL AND MECHANICAL PROPERTIES OF BRICKS AND MORTAR IN HISTORIC STRUCTURES

Mirjana Bošnjak-Klečina, Silva Lozančić

Preliminary notes

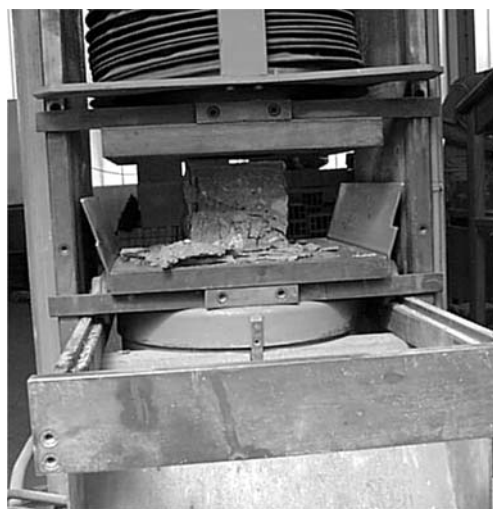
Figure 3 Compression failure of the brick
Slika 3. Tlačni slom opeke

Compressive strength. The compressive strength of brick elements has been tested by gradual increase of the compressive force up to the failure of sample, according to the procedure described in the norm [8]. The tests were performed on a sample made by joining two halves of the same brick. The test is shown in Figures 2 and 3. Results of tests are shown in Tab. 5.

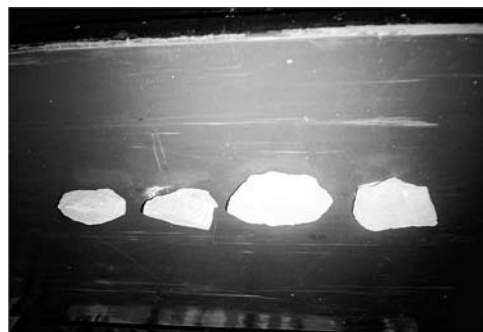
Figure 4 The samples removed from the building
Slika 4. Uzorci izvađeni iz građevine

The old mortar samples were taken from the 18th century structure located at the Tvrdja in Osijek, built at the same time and with the same material as the observed structures. Because of the difficulties connected with finding the right undisturbed samples the scope of investigation has been limited. The samples were obtained by removing the mortar from the existing building.

The samples are presented in Figures 4 and 5.

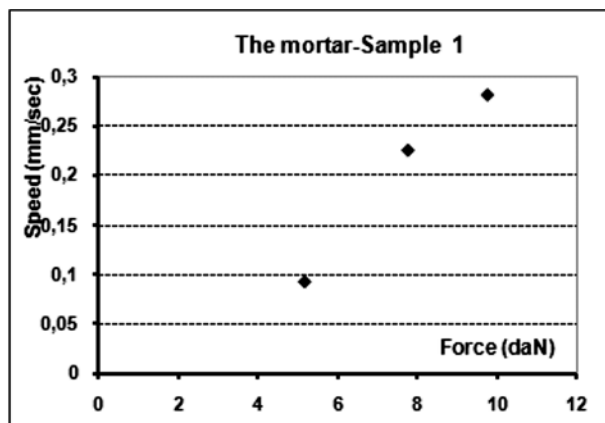
Figure 16 The mortar of strength 10,00 MPa
Slika 16. Mort čvrstoće 10,00 MPa

samples), the total number of drillings being 72. Selected rotational speed of power drill was 600 rpm, the diameter of drilling bit was 6 mm (drilling bit for concrete, tempered steel tip). The expected drill depth was 40 mm. Time was measured for this depth of drilling at constant speed and force for all three holes (the number of holes on one sample was restricted by the size of the sample). It was evident that in tests on the samples of great strength there were almost no differences in the depth of drilling regarding the changes in applied force, while on the samples of compressive strength the samples failed because of their very small tensile strength. On the samples of medium strength, the functional relation of force (the added weight) and drilling time (Figures 16 and 17) may be foreseen. The shown penetration speeds correspond to the mean values in three measurements.
