Project 3 - Evaluation of seismic performance of a template design RC school building before and after strengthening

Source / Izvornik: **Model Validation and Simulation, 2013, 309 - 318**

Project 3 — Evaluation of seismic performance of a template design RC school building before and after strengthening

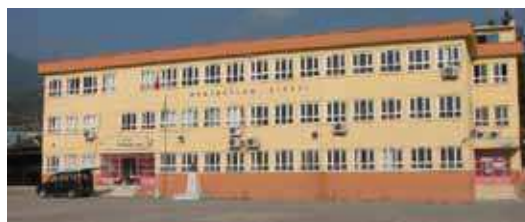
Figure 1 — Front view of the study object [1]

The considered school building is one of three school buildings in Hatay (Turkey), which could be dynamically investigated before and after strengthening. It is a 3-story RC frame structure building and was constructed in 1997 according to the 1972 earthquake design code (see Fig. 1).

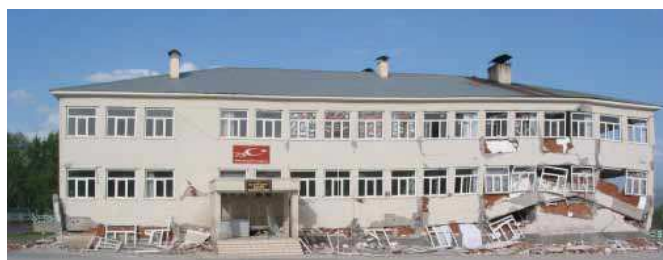
Figure 3 — Damage of a school building caused by the 1st May Bingöl earthquake [2]

The magnitude 6.6 Bingöl (Türkiye) earthquake on May 1, 2003 caused severe damages and collapse to school buildings (see Figure 3). The comparison of the general layouts from the damage structures and the study object indicates the representativeness of the studied object and provides the opportunity to adopt the experiences from the Bingöl earthquake to the study area Antakya. Thus, the results of the damage prognosis can be compared with the observed damages on school building with a nearly identical (template) design for a known seismic action.
