Seismic Assessment of a Modernist Building in Sarajevo, Bosnia and Herzegovina

Abstract: This paper presents an in-depth analysis of the Kopčić House, a significant example of modernist architecture in Sarajevo, Bosnia and Herzegovina, focusing on its structural-specific features and seismic performance. The Kopčić House embodies a confined masonry structure with innovative construction features, combining load-bearing masonry walls with reinforced concrete elements. This architectural approach was pioneering for its time, combining traditional construction methods with innovative materials and techniques. Detailed analysis using numerical modeling techniques, specifically 3D modeling with the 3Muri software (Vers.14.2.0.4), was conducted to assess the seismic resilience of the structure. The analysis considered different load distributions and eccentricities to comprehensively evaluate the building's response to lateral forces. The findings of this research reveal the structural capacity and potential vulnerabilities of the Kopčić House when subjected to seismic events. While the building demonstrates inherent strength due to its confined masonry design, areas requiring structura

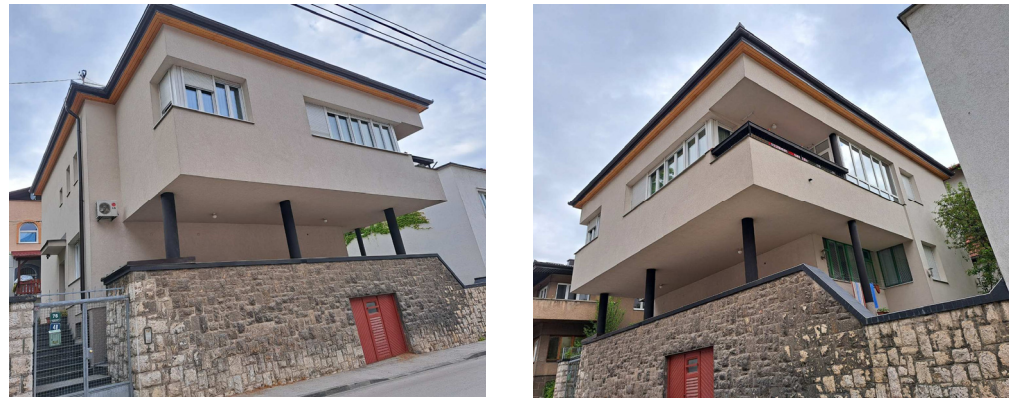
Figure 5. Kopčić House today (author's source).

Noteworthy are the specific measurements defining the building’s spatial characteristics. The basement’s clear height is determined to be 2.60 m, while the subsequent floors

have a height of 3.40 m, with the roof reaching a height of 3.83 m. The cumulative height of the structure is 13.20 m.

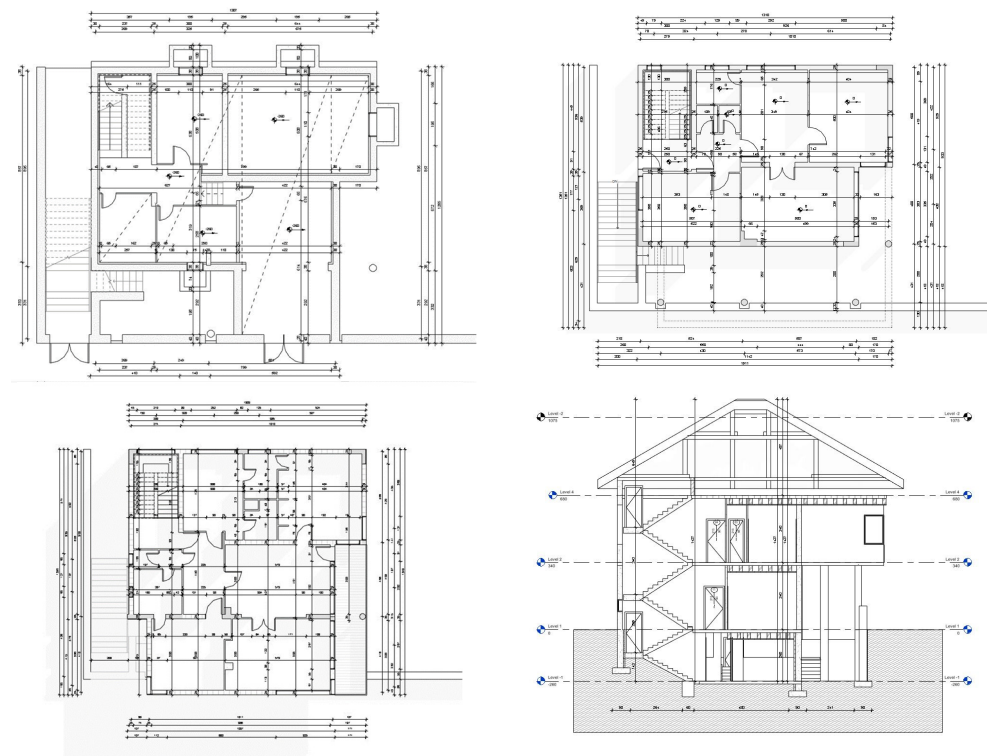
Figure 6. The original blueprint of the buildings was obtained from the Kopčić family. Reproduced with permission from the Kopčić family.

In the plan view, the building exhibits a near-regular square shape, delineated by axis spans of 13.10 m \times 13.50 m (see Figure 6), illustrating a deliberate architectural symmetry. All external walls fulfill load-bearing functions, providing essential structural support throughout the building. Moreover, the structure features longitudinal load-bearing walls positioned nearly at its midpoint, extending throughout all the floors. Adjacent to the staircase, a transversal load-bearing wall spans the entirety of the structure, guaranteeing structural stability and integrity. Nonetheless, a distinct internal transverse wall in the basement fails to extend to the upper floors. The locations of the non-load-bearing walls are not the same on all the floors but are arbitrarily positioned. The position of the load-bearing walls, along with the four columns, renders the structure structurally asymmetrical.

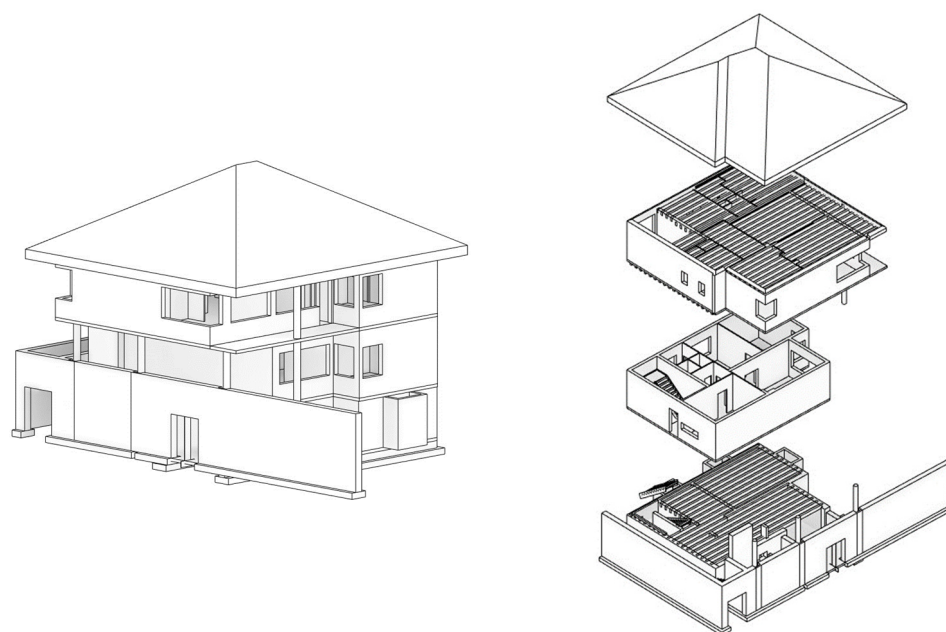
Figure 7. BIM model.

From the detailed measurements extracted from the architectural drawings, a comprehensive 3D Building Information Modeling (BIM) model was meticulously constructed, as illustrated in Figure 7. This BIM model serves as a digital representation of the physical building, incorporating precise geometric and spatial data to accurately depict its structural elements, architectural features, and overall layout in a virtual environment.

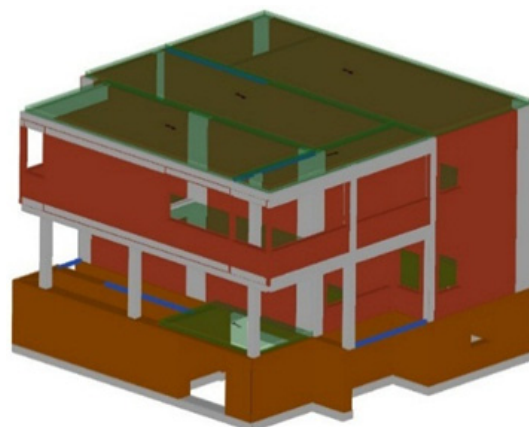
Figure 8. Three-dimensional model of the analyzed building [16].

The 3D model is presented in Figure 8.

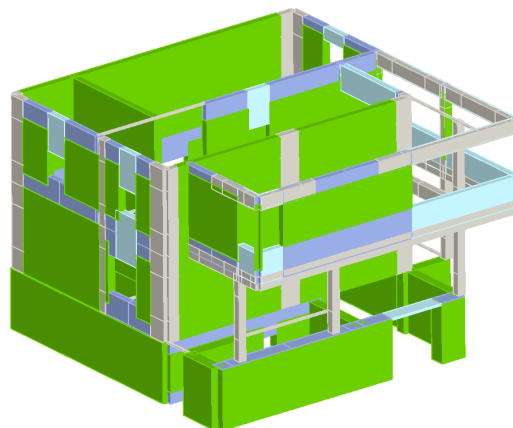
Figure 9. Three-dimensional view of the static analysis results of the structure.

Based on the analysis, all walls have successfully passed both checks. The overall result for the entire structure is presented in Figure 9, where all elements are indicated in green, signifying the fulfillment of both conditions outlined in Eurocode 6: the slenderness check $h_{ef}/t_{ef} \leq \lambda_{lim} = 27$ and the condition for vertical loading $N_{Ed} \leq N_{Rd}$. Notably, there is a significant difference observed between the values of N_{Ed} and N_{Rd} , with the maximum value obtained for wall 2 being $N_{Ed}/N_{Rd} = 0.43$ compared to the unity threshold, indicating underutilization of elemental capacity. Additionally, it is worth noting that the slenderness criteria are satisfied as the maximum calculated value $h_{ef}/t_{ef} = 13.60$ is well below the threshold of 27.

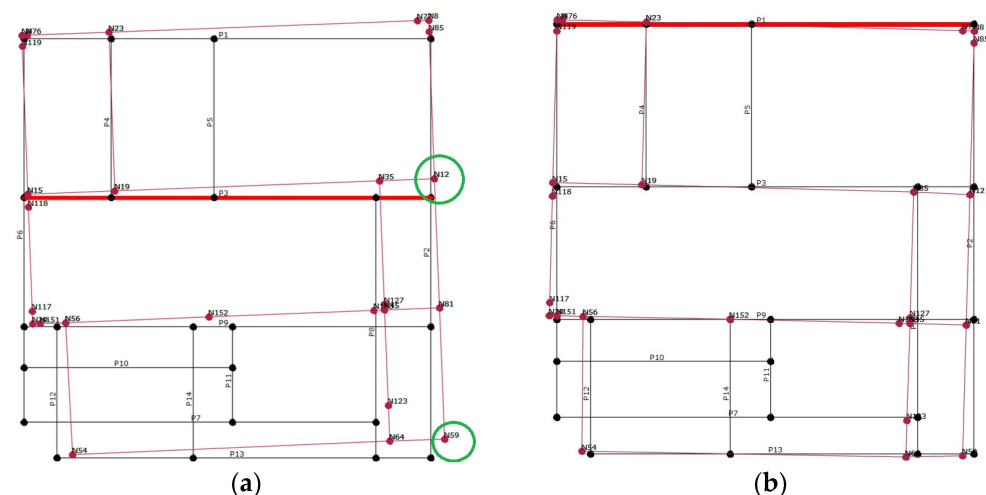
Figure 10. Eigen modes. (a) First eigen mode, Y-direction; (b) second eigen mode, X-direction.

It is interesting to note that both modes are not purely translational; there is also some rotational motion, as evident in Figure 10. Torsional modes can occur in masonry structures, especially when there are asymmetries or irregularities in the distribution of mass and stiffness. The torsion is primarily attributed to the asymmetric positioning of the load-bearing walls, which results in uneven distribution of forces throughout the structure. Additionally, the presence of the four columns introduces structural irregularities, further exacerbating torsional effects. Moreover, the inclusion of confining elements, such as tie-columns and “reinforcement walls,” contributes to the complex interplay of forces within the structure, ultimately leading to a discrepancy between the center of mass and the center of stiffness. These discrepancies amplified torsional forces, making it a significant factor in the structural behavior of the system.

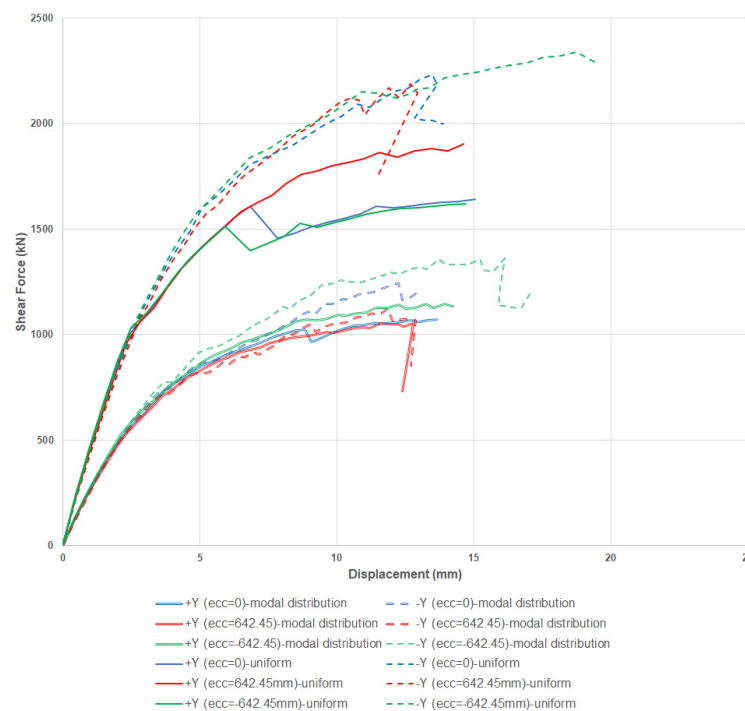
Figure 11. Pushover in the Y-direction.

Additionally, to provide a comprehensive view of the structure's performance, capacity curves for both the Y- and X-directions were generated. These curves, depicted in Figures 11 and 12, offer valuable insights into the structure's ability to withstand lateral loads from different orientations.

Under uniform force distribution, the structure reaches a maximum force of 1030.1 kN, with a corresponding displacement of 2.52 mm before transitioning into nonlinear behavior. This force signifies the formation of initial cracks in the wall, indicating the structural capacity. Interestingly, there is a decrease in capacity for the +Y-direction when no eccentricity and positive eccentricities are considered, which is not observed when the eccentricity is negative. Upon examining the damage to the wall elements, it was observed that this decrease is attributed to the shear and flexure failure of one of the “reinforcement walls” and one of the masonry walls in the Y-direction, which is in line with the findings [38–40]. The highest capacity is achieved in the +Y-direction with a +5% accidental eccentricity, reaching a maximum shear force of 1919.8 kN and a maximum displacement of 18.6 mm (Figure 11).

In all three capacity curves (−Y-direction), the ductility value remains consistent. Notably, the behavior in the −Y-direction exhibits remarkable similarity across all cases—no eccentricity, positive eccentricity, and negative eccentricity—although a significantly higher ductility is observed for negative eccentricity. This suggests that the structural response to lateral loads in the −Y-direction is largely unaffected by the presence or absence of eccentricity. However, when negative eccentricity is introduced, the structure demonstrates a notable increase in ductility, indicating its ability to deform plastically under load. The increase in displacement is 43.3% compared to the other two capacities in the −Y-direction, while the shear force increases by 17.9% compared to the +Y-direction. These
