Seismic Assessment of a Modernist Building in Sarajevo, Bosnia and Herzegovina

Source / Izvornik: Buildings, 2024, 14

Keywords: confined masonry; modernist architecture; seismic analysis; 3Muri; pushover analysis

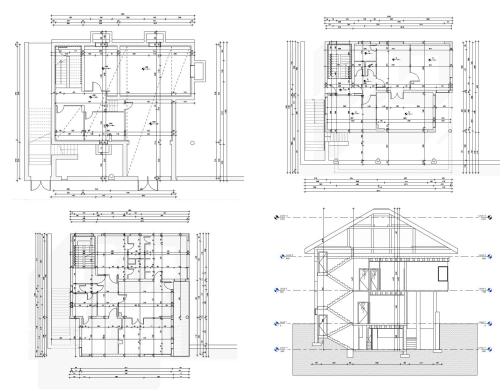
Figure 6. The original blueprint of the buildings was obtained from the Kopčić family. Reproduced with permission from the Kopčić family.

In the plan view, the building exhibits a near-regular square shape, delineated by axis spans of $13.10~\mathrm{m}\times13.50~\mathrm{m}$ (see Figure 6), illustrating a deliberate architectural symmetry. All external walls fulfill load-bearing functions, providing essential structural support throughout the building. Moreover, the structure features longitudinal load-bearing walls positioned nearly at its midpoint, extending throughout all the floors. Adjacent to the staircase, a transversal load-bearing wall spans the entirety of the structure, guaranteeing structural stability and integrity. Nonetheless, a distinct internal transverse wall in the basement fails to extend to the upper floors. The locations of the non-load-bearing walls are not the same on all the floors but are arbitrarily positioned. The position of the load-bearing walls, along with the four columns, renders the structure structurally asymmetrical.

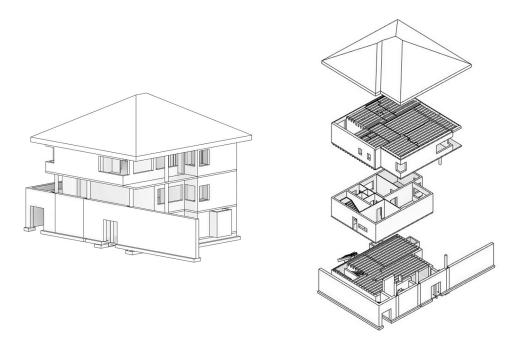
Figure 7. BIM model.

From the detailed measurements extracted from the architectural drawings, a comprehensive 3D Building Information Modeling (BIM) model was meticulously constructed, as illustrated in Figure 7. This BIM model serves as a digital representation of the physical building, incorporating precise geometric and spatial data to accurately depict its structural elements, architectural features, and overall layout in a virtual environment.

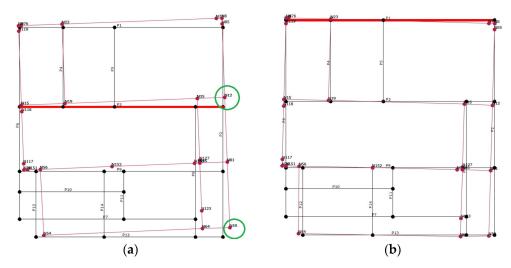
Figure 10. Eigen modes. (a) First eigen mode, Y-direction; (b) second eigen mode, X-direction.

It is interesting to note that both modes are not purely translational; there is also some rotational motion, as evident in Figure 10. Torsional modes can occur in masonry structures, especially when there are asymmetries or irregularities in the distribution of mass and stiffness. The torsion is primarily attributed to the asymmetric positioning of the load-bearing walls, which results in uneven distribution of forces throughout the structure. Additionally, the presence of the four columns introduces structural irregularities, further exacerbating torsional effects. Moreover, the inclusion of confining elements, such as tie-columns and "reinforcement walls," contributes to the complex interplay of forces within the structure, ultimately leading to a discrepancy between the center of mass and the center of stiffness. These discrepancies amplified torsional forces, making it a significant factor in the structural behavior of the system.

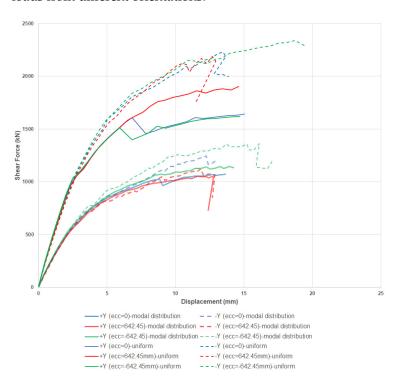
Figure 11. Pushover in the Y-direction.

Additionally, to provide a comprehensive view of the structure's performance, capacity curves for both the Y- and X-directions were generated. These curves, depicted in Figures 11 and 12, offer valuable insights into the structure's ability to withstand lateral loads from different orientations.

Under uniform force distribution, the structure reaches a maximum force of 1030.1 kN, with a corresponding displacement of 2.52 mm before transitioning into nonlinear behavior. This force signifies the formation of initial cracks in the wall, indicating the structural capacity. Interestingly, there is a decrease in capacity for the +Y-direction when no eccentricity and positive eccentricities are considered, which is not observed when the eccentricity is negative. Upon examining the damage to the wall elements, it was observed that this decrease is attributed to the shear and flexure failure of one of the "reinforcement walls" and one of the masonry walls in the Y-direction, which is in line with the findings [38–40]. The highest capacity is achieved in the +Y-direction with a +5% accidental eccentricity, reaching a maximum shear force of 1919.8 kN and a maximum displacement of 18.6 mm (Figure 11).

In all three capacity curves (—Y-direction), the ductility value remains consistent. Notably, the behavior in the —Y-direction exhibits remarkable similarity across all cases—no eccentricity, positive eccentricity, and negative eccentricity—although a significantly higher ductility is observed for negative eccentricity. This suggests that the structural response to lateral loads in the —Y-direction is largely unaffected by the presence or absence of eccentricity. However, when negative eccentricity is introduced, the structure demonstrates a notable increase in ductility, indicating its ability to deform plastically under load. The increase in displacement is 43.3% compared to the other two capacities in the —Y-direction, while the shear force increases by 17.9% compared to the +Y-direction. These

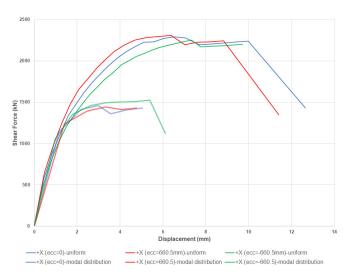
Figure 12. Pushover in the X-direction.

In the X-direction, particular attention is directed towards the positive direction. Upon comparing the structural response between the uniform distribution and the modal distribution, a notable discrepancy in structural capacity and ductility becomes apparent. The uniform distribution consistently demonstrates a higher structural capacity and greater ductility compared to the modal distribution. Interestingly, when examining the capacity curves for uniform distribution across various eccentricity values, a remarkable similarity is observed, indicating a consistent structural response regardless of eccentricity. This uniformity in response is also reflected in the set of modal distributions for different eccentricities.

However, the modal distribution with a +5% eccentricity presents a distinct behavior characterized by its lower capacity and ductility. In this configuration, the shear force measures 1442 kN, accompanied by a maximum displacement of 5.63 mm. Despite experiencing a minor increase of 5.4% in shear force compared to other configurations, this particular modal distribution exhibits the structure's reduced resilience under positive eccentricity conditions (Figure 12). Conversely, the uniform distribution demonstrates a significantly higher capacity compared to the modal distribution. The maximum obtained shear force in this scenario reaches an impressive 2307.8 kN (refer to Figure 12), underscoring the structural robustness achievable with uniform load distribution across the structure.

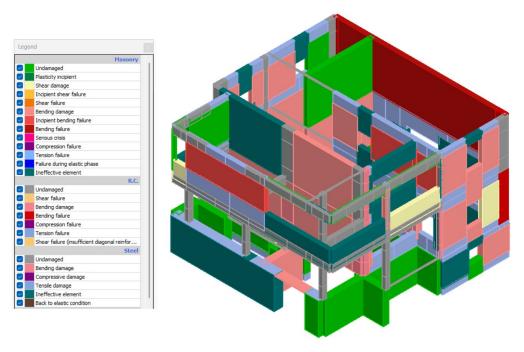
Figure 13. Damage of the structure during analysis No. 23.

In Figure 13, the damage incurred by the structural elements under loading case 23 (+Y-direction) is depicted, revealing a vulnerability index of 0.632. This index indicates a capacity of only 63.2%, highlighting significant structural vulnerability. Upon closer examination in the final step of the analysis, predominant damages are observed around the structural openings, primarily manifested as bending failures. Furthermore, evidence of shear damage and bending failure is observed within the "reinforced walls", further emphasizing the structural challenges encountered. In the masonry walls, signs of incipient bending failure gradually progress to full bending failure, particularly pronounced along the outer longitudinal wall parallel to the street façade. Additionally, on the first floor, shear damage is evident, particularly notable around the balcony area.

This comprehensive evaluation of Figure 13 underscores the complex array of structural vulnerabilities presented across various elements under loading case 23. The observed damages provide valuable insights into the structural performance under applied loads, emphasizing the importance of mitigation strategies in enhancing structural resilience.

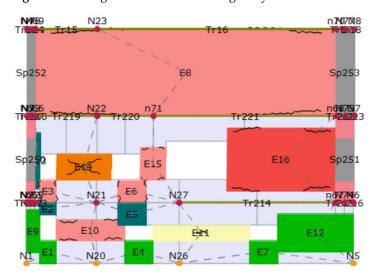
Figure 14. Damage of the wall during analysis no. 11.

The structural vulnerabilities are demonstrated in the form of apparent damage to various structural elements, as delineated by Figure 14. Notably, the "reinforcement walls" and tie-columns exhibit discernible signs of bending damage, indicative of structural

distress and compromised load-bearing capacity. Furthermore, the masonry walls display evident indications of bending damage, particularly around openings, progressing to incipient bending damage in localized regions. Additionally, instances of shear damage and even shear failure are observed in select locations, further emphasizing the structural vulnerabilities and susceptibility to loading-induced damage.
