*Source / Izvornik:* **Tehnički vjesnik, 2010, 17, 209 - 215**

# TESTING OF PHYSICAL AND MECHANICAL PROPERTIES OF BRICKS AND MORTAR IN HISTORIC STRUCTURES

*Mirjana Bošnjak-Klečina, Silva Lozančić*

Preliminary notes

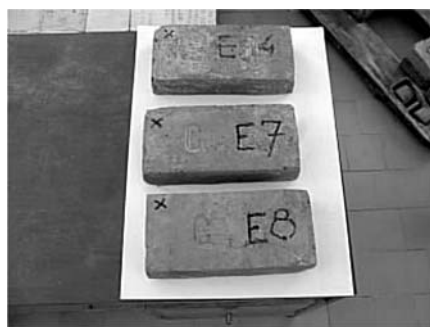
Figure 1 Tested brick samples  
Slika 1. Uzorci ispitanih opeka

The testing has been carried out in accordance with the valid European standards. The samples of old bricks have been taken from three locations: St. Michael's church in Osijek, St. Philip and Jacob's church in Vukovar and Eltz's manor house in Vukovar. The bricks were made in 18<sup>th</sup> century, most likely in brickyards near the mentioned structures. The samples are shown in Fig. 1. The new brick is solid masonry unit manufactured in a modern Slavonian brickyard. Each testing has been carried out on one sample

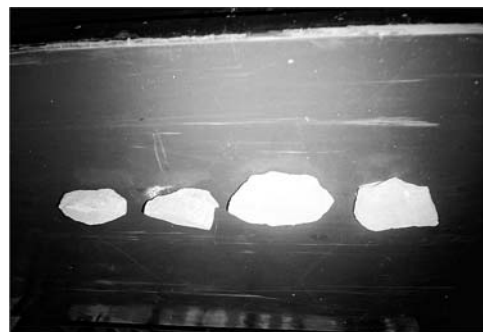
**Figure 4** The samples removed from the building  
**Slika 4.** Uzorci izvađeni iz građevine

The old mortar samples were taken from the 18<sup>th</sup> century structure located at the Tvrdja in Osijek, built at the same time and with the same material as the observed structures. Because of the difficulties connected with finding the right undisturbed samples the scope of investigation has been limited. The samples were obtained by removing the mortar from the existing building.

The samples are presented in Figures 4 and 5.

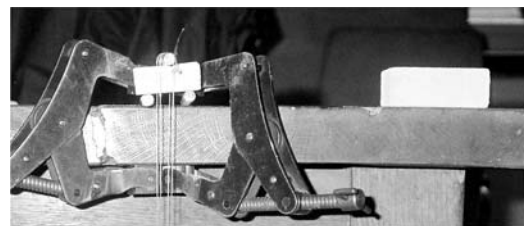
**Figure 5** Samples prepared for testing  
**Slika 5.** Uzorci pripremljeni za ispitivanje

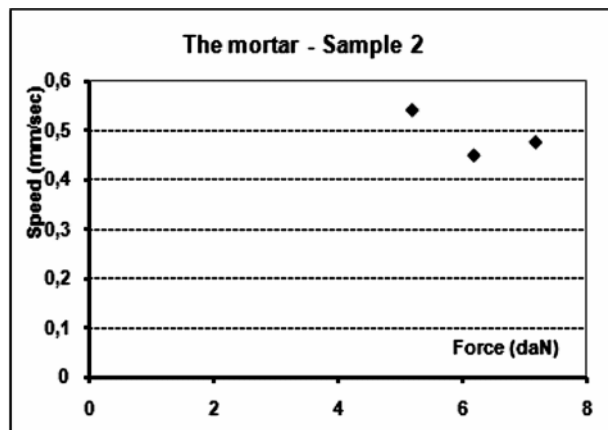
Figure 17 The mortar of strength 1,80 MPa  
Slika 17. Mort čvrstoće 1,80 MPa

samples), the total number of drillings being 72. Selected rotational speed of power drill was 600 rpm, the diameter of drilling bit was 6 mm (drilling bit for concrete, tempered steel tip). The expected drill depth was 40 mm. Time was measured for this depth of drilling at constant speed and force for all three holes (the number of holes on one sample was restricted by the size of the sample). It was evident that in tests on the samples of great strength there were almost no differences in the depth of drilling regarding the changes in applied force, while on the samples of compressive strength the samples failed because of their very small tensile strength. On the samples of medium strength, the functional relation of force (the added weight) and drilling time (Figures 16 and 17) may be foreseen. The shown penetration speeds correspond to the mean values in three measurements.
