# EXPERIMENTAL EXAMINATION OF EROSION THREATENED WATERFALLS ON TUFF BEDS PROTECTION – NATURAL LANDSCAPE, HISTORICAL AND CULTURAL VALUES ON THE EXAMPLE OF THE TOWN JAJCE

Preliminary notes

The possibilities of technical interventions in waterfall area formed in heterogeneous tuff sediments are described in this paper. The river Pliva's waterfall was chosen for the test site, as it is a unique natural phenomenon placed in the middle of the old town of Jajce. The applicable methods for technical stabilization of waterfall are conditioned by natural, urban, architectural, historical and specific values of the town landscape. That is why that concrete or reinforced concrete structure should be avoided and priority given to binders for natural tuff detritus that do not change the shape or color of naturally hardened tuff are preferred. Laboratory experiments on a large number of samples have shown good results when micro-cement was injected into tuff beds, but the usability of other injection suspensions was also examined on the research region. The injection suspensions were adjusted to the tuff lithological composition. Comparisons of the control samples in laboratory and on site have

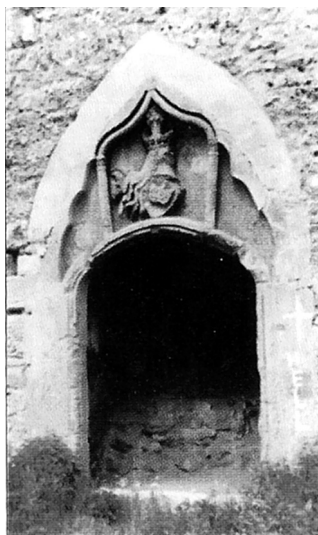
Figure 3 The Royal portal and emblem  
Slika 3. Kraljevski portal i grb

- The Royal port with the shield of Kotromanić from 15<sup>th</sup> century. The emblem was shaped in tuff in Gothic style and is composed of a crown shaped like lily. The Crown, armor and flower bouquet are placed in the middle. The emblem was shaped in tuff in Gothic style, [2].
- The Banjaluka gate, earlier known as Franciscan doors, dating from the bricklaying time of Jajce. The main construction material is shaped tuff, [2].

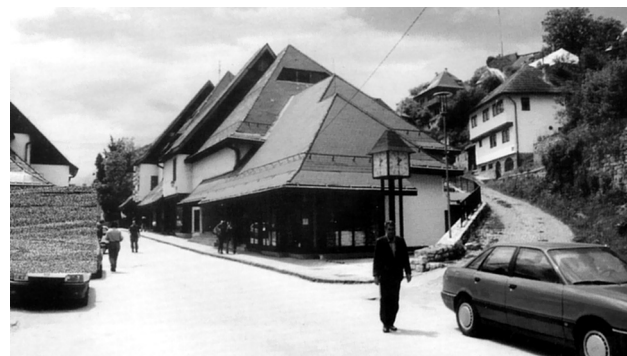
Figure 6 Shopping center "Jajce" built during 1976.  
Slika 6. Robna kuća "Jajce" izgrađena 1976.

- Design of shopping centre "Jajce" in the centre of the town won a 2<sup>nd</sup> prize on International congress of architects UIA ("Unité internationale des architectes") held in Mexico in 1978. Authors of this design are R. Jandrić, DŽ. Karić, N. Kurto and G. Ferušić from Zagreb. The shopping centre "Jajce" is an example of harmonious and relatively careful embedding in the existing urban-architectural and landscape unit, [2].
- The town park by the Pliva waterfall with its position and design is bonding the old town's core to the magnificent waterfall. The town's park is the best example of integration in and coexistence of natural regional marks and historical urban-architectural intervention, [2].

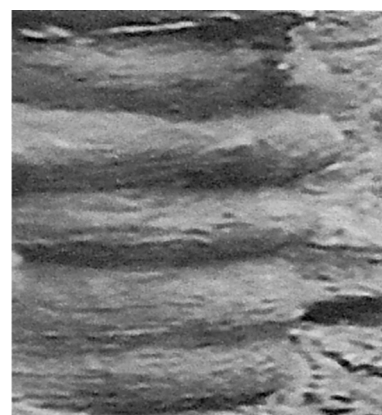
For tuff sand and dust jet grouting with one-fluid-direct injecting can be used, which for uses flow of cement suspension destruction and bonding of the ground. This technique is used for materials that closely represent the composition and granulation of tuff sand and dust. The body of injected mass that was dug resembled hard tuff with homogenous texture (Figure 10).

Figure 10 Ground after jet grouting  
Slika 10. Tlo injektirano mlaznim postupkom

Comparing the samples injected with micro-cement to the samples after jet grouting it is easy to see that jet grouting leaves larger amount of pure cement. In extremely heterogeneous tuff sediments, though, jet grouting is questionable in regions with caverns and hard tuff.
