## BACK TO THE FUTURE – ANDRIJA MOHOROVIČIĆ LECTURE (1909) & ZAGREB (2020) M5.5 EARTHQUAKE

**Abstract:** This review paper relates original Mohorovičić, A. lecture *DJELOVANJE POTRESA NA ZGRADE* (1909, 1911) and its English translation *EARTHQUAKE EFFECTS ON BUILDINGS* (2009) with M5.5 Zagreb 2020 earthquake damage. Mohorovičić said in Introduction of his lecture in 1909: “another strong earthquake is needed to remind people that the building techniques should be further developed and improved...”. Oliver Wendell Holmes (1809-1894) said once: “The young man knows the rules, but the old man knows the exceptions”. This should remind us that going **Back to the Future** after strong earthquake, we must go **Back to the Past**, and look after **Mohorovičić’s 15 rules how to build earthquake-resistant buildings**. He tells us how to build, and unfortunately, we were left unprepared again and didn’t listen wisdom words of an “old man”.

Review paper

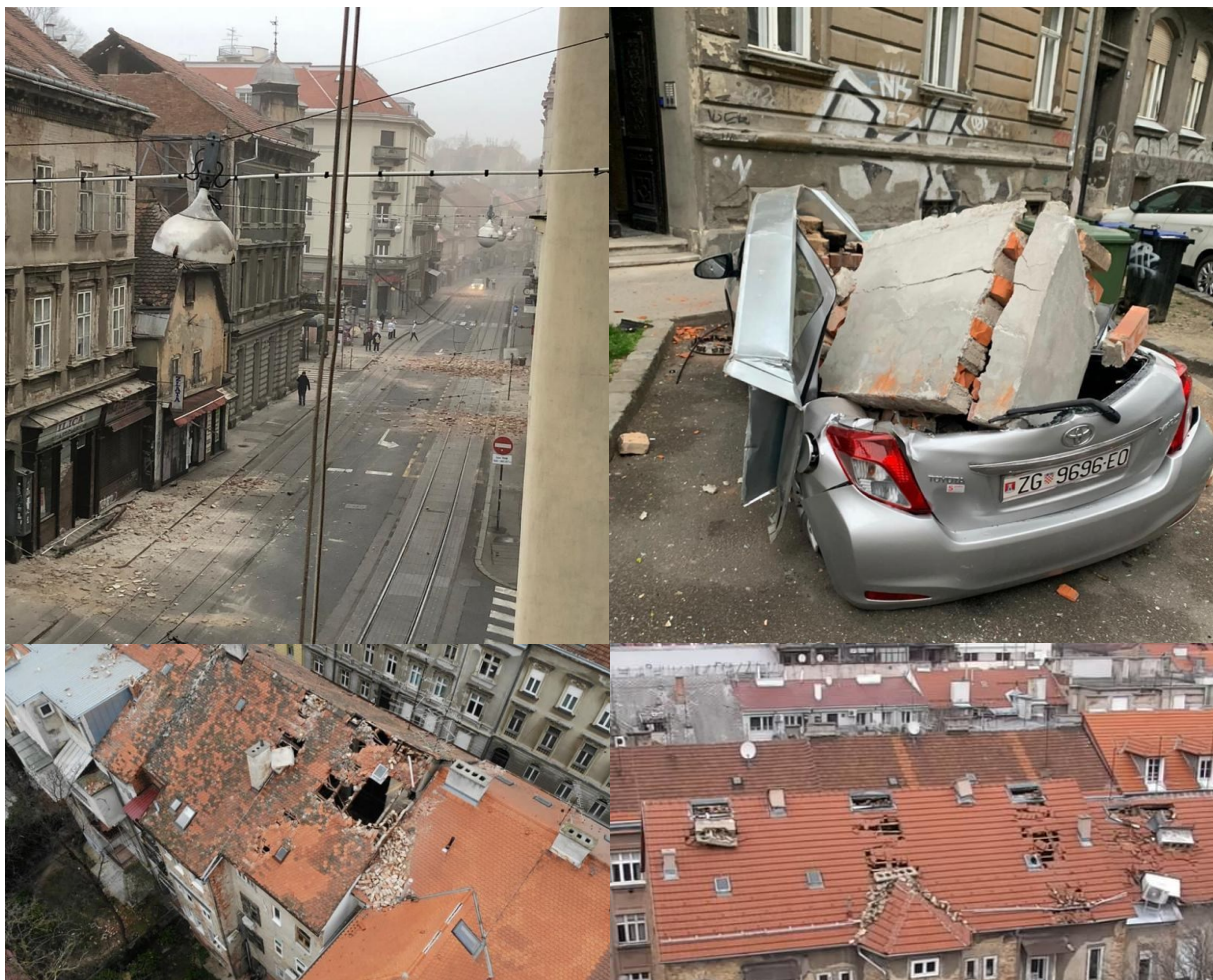
**Figure 5.** Damage in Zagreb after 22 March M5.5 earthquake. Noticeable roof tile loss and chimney collapse

With respect to **Figures 4 to 8** and Mohorovičić's 15 advices stated in **Table 1**, one can easily correlate e.g. rules 10 to 15 with building damage in **Figure 5** or rules 6 to 9 with building damage in **Figure 8**. **The cultural heritage buildings as those in Figures 4, 6 and 7, are very sensitive and require multidisciplinary approach.** The obstacles in effective implementation of the earthquake risk reduction rules (such as those stated in **Table 1**) arise when dealing with existing built environment. The detail and degree to which building's seismic performance could be improved for expected future events, meets the technical and non-technical obstacles. The latter is related unwillingness and/or inability due to lack of initiative, lack of finances or in general the lack of proper understanding of earthquake and its consequences. The technical part i.e. knowledge on building construction

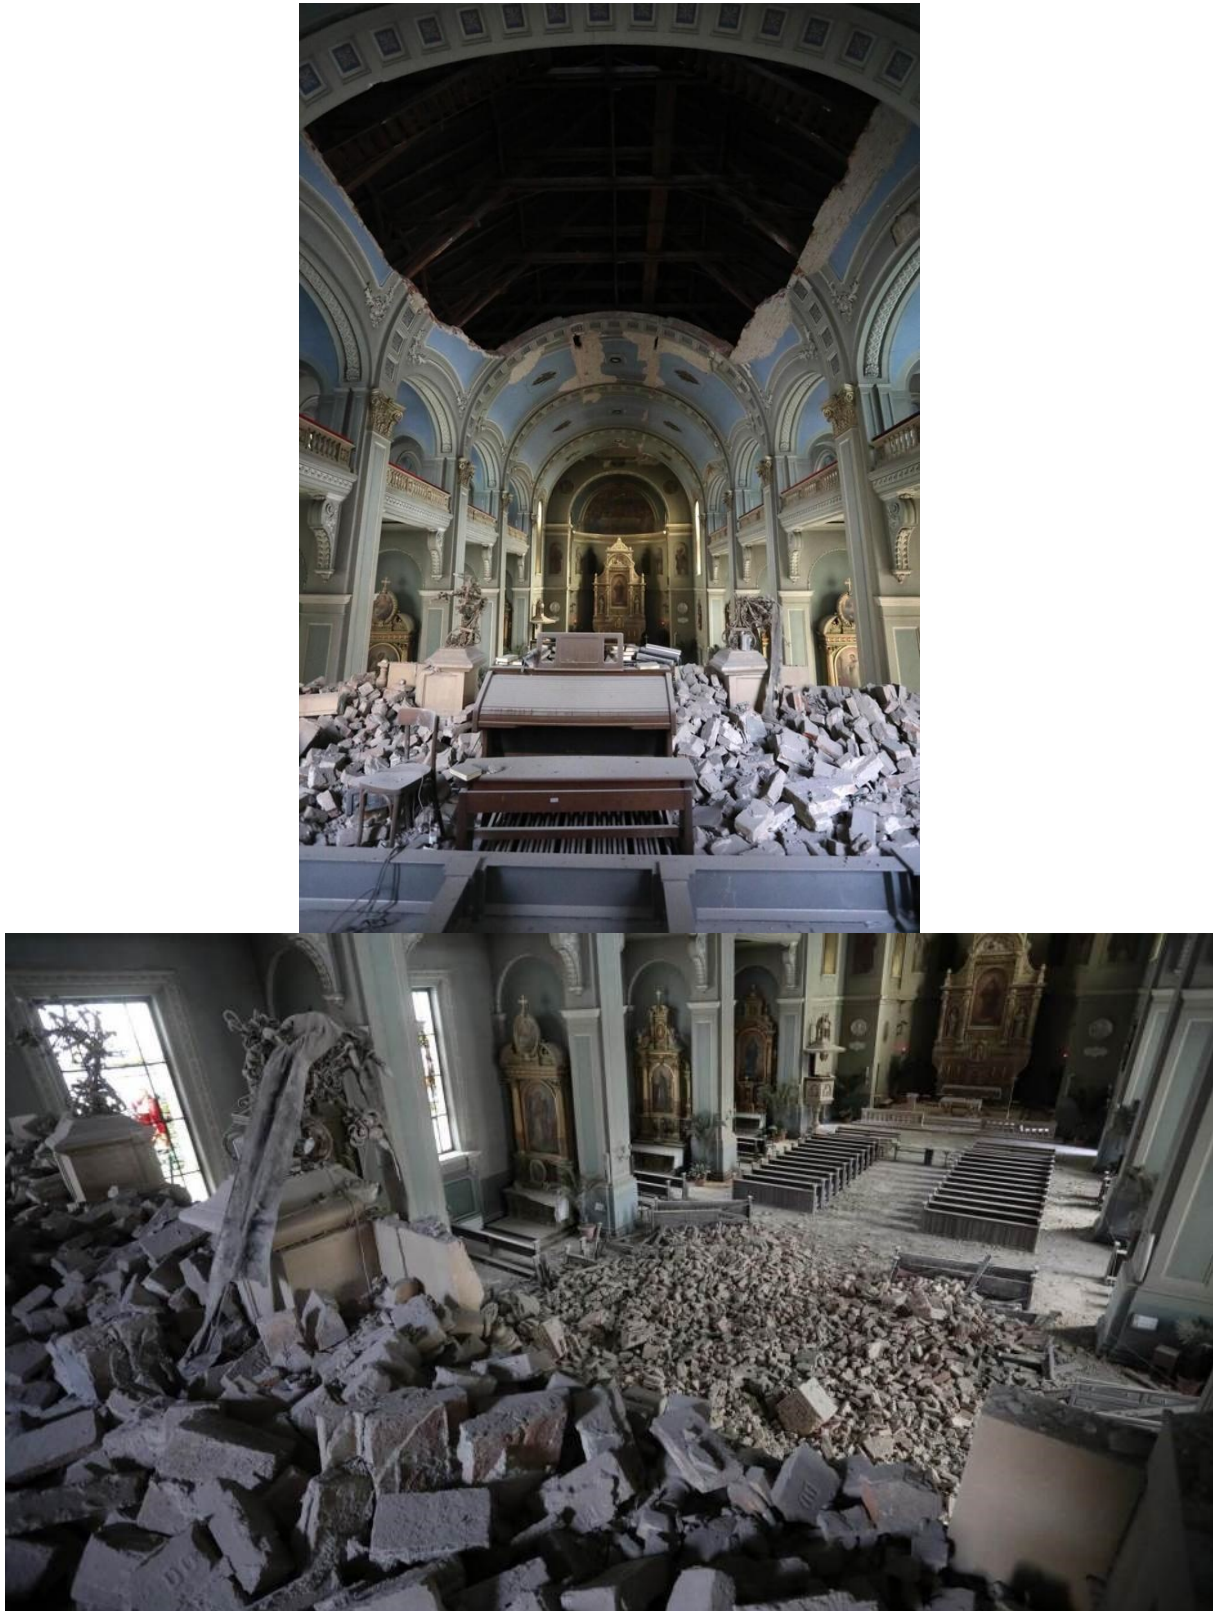
**Figure 6.** Damage to cultural heritage: Basilica of the Heart of Jesus from 1902  
<https://www.24sata.hr/news/crkva-u-palmiticevoj-unistena-uruso-se-strop-iznad-ulaza-682556>

The problem of building performance, as observed in **Figures 4 to 8**, lies partially in inadequate design with respect to corresponding seismic demand, and in other part in lack of implementation, or lack in general, of available research solutions for their protection (e.g. the heritage building Shrine of Saint Mary of Remete dating from 1786 shown in **Figure 7** was already once severely damaged in 1880 Zagreb earthquake). For the seismic safety purposes, it is therefore required to adopt and enforce the seismic rules and regulations (e.g. see **Table 1**), with particular attention to cultural heritage sites.

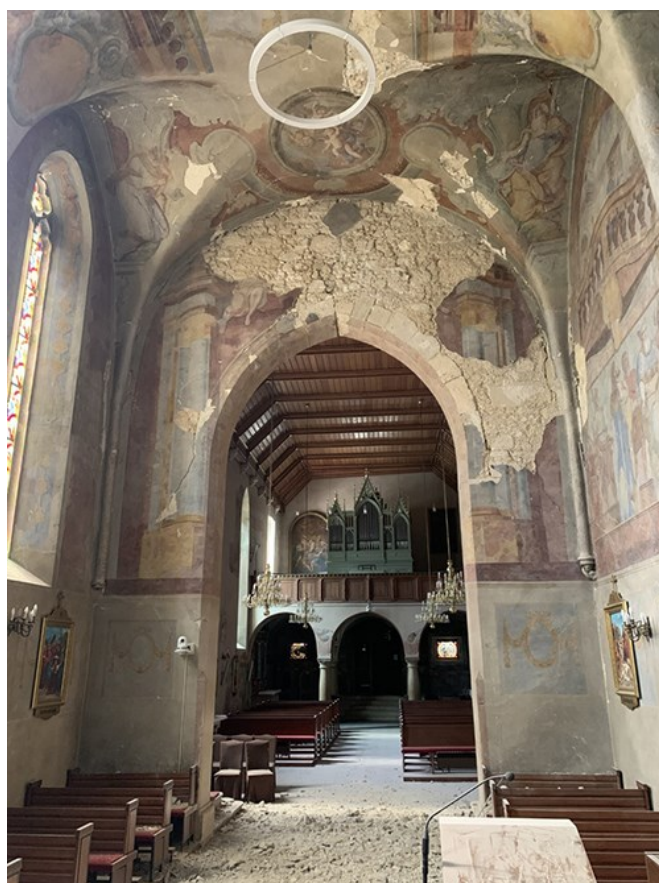
**Figure 7.** Damage to cultural heritage: Shrine of Saint Mary of Remete from 1786  
<https://www.24sata.hr/news/pogledajte-trenutak-potresa-u-crkvi-u-remetama-u-zagrebu-682565>

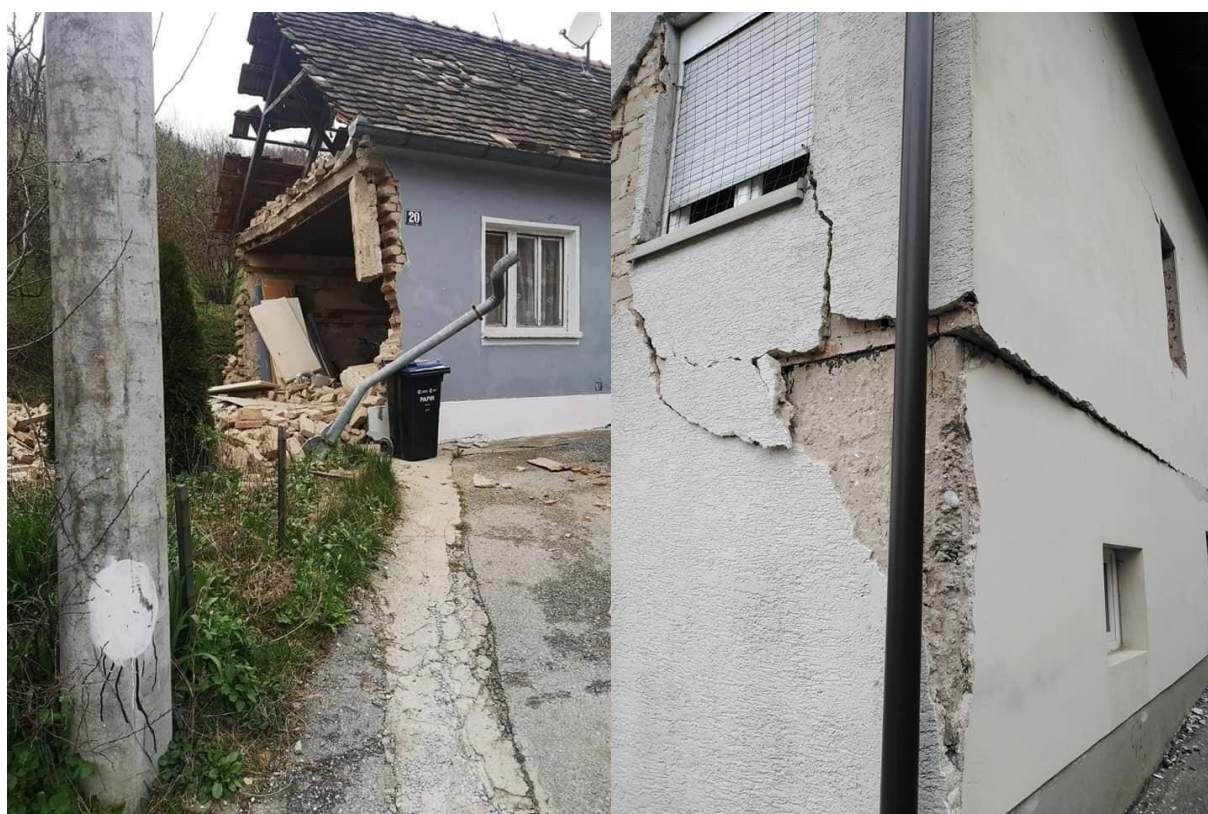
**Figure 8.** Heavily damaged family house near the epicenter.  
<https://dnevnik.hr/vijesti/hrvatska/potres-u-zagrebu-ostali-bez-domova---598777.html>
