# EXPERIMENTAL EXAMINATION OF EROSION THREATENED WATERFALLS ON TUFF BEDS PROTECTION – NATURAL LANDSCAPE, HISTORICAL AND CULTURAL VALUES ON THE EXAMPLE OF THE TOWN JAJCE

Preliminary notes

The possibilities of technical interventions in waterfall area formed in heterogeneous tuff sediments are described in this paper. The river Pliva's waterfall was chosen for the test site, as it is a unique natural phenomenon placed in the middle of the old town of Jajce. The applicable methods for technical stabilization of waterfall are conditioned by natural, urban, architectural, historical and specific values of the town landscape. That is why that concrete or reinforced concrete structure should be avoided and priority given to binders for natural tuff detritus that do not change the shape or color of naturally hardened tuff are preferred. Laboratory experiments on a large number of samples have shown good results when micro-cement was injected into tuff beds, but the usability of other injection suspensions was also examined on the research region. The injection suspensions were adjusted to the tuff lithological composition. Comparisons of the control samples in laboratory and on site have

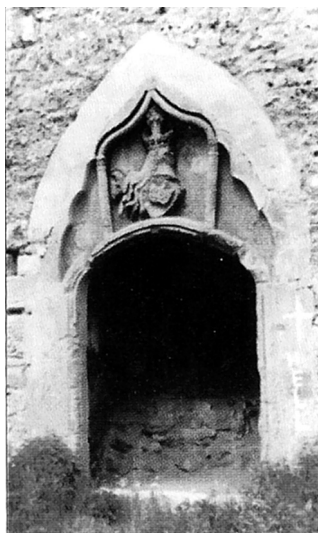
Figure 3 The Royal portal and emblem  
Slika 3. Kraljevski portal i grb

- The Royal port with the shield of Kotromanić from 15<sup>th</sup> century. The emblem was shaped in tuff in Gothic style and is composed of a crown shaped like lily. The Crown, armor and flower bouquet are placed in the middle. The emblem was shaped in tuff in Gothic style, [2].
- The Banjaluka gate, earlier known as Franciscan doors, dating from the bricklaying time of Jajce. The main construction material is shaped tuff, [2].

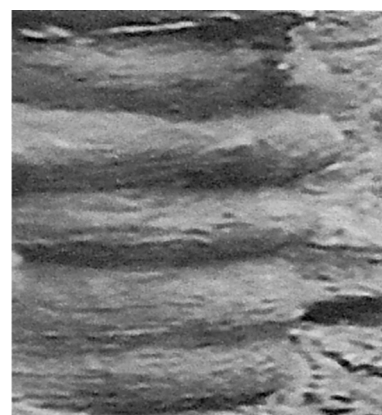
Figure 10 Ground after jet grouting  
Slika 10. Tlo injektirano mlaznim postupkom

For tuff sand and dust jet grouting with one-fluid-direct injecting can be used, which for uses flow of cement suspension destruction and bonding of the ground. This technique is used for materials that closely represent the composition and granulation of tuff sand and dust. The body of injected mass that was dug resembled hard tuff with homogenous texture (Figure 10).

Comparing the samples injected with micro-cement to the samples after jet grouting it is easy to see that jet grouting leaves larger amount of pure cement. In extremely heterogeneous tuff sediments, though, jet grouting is questionable in regions with caverns and hard tuff.
