Source / Izvornik: **Journal of Earthquake Engineering, 2014, 18, 113 - 146**

Influence of Openings, With and Without Confinement, on Cyclic Response of Infilled R-C Frames — An Experimental Study

V. Sigmund & D. Penava

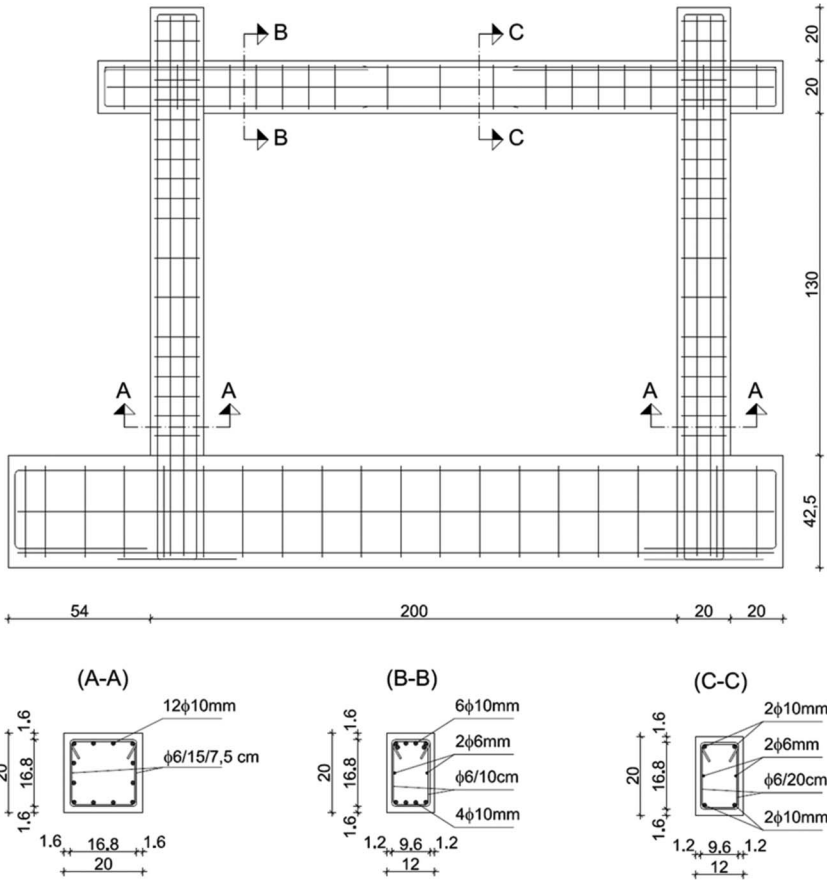
FIGURE 1 Reinforcement details and specimen's dimensions (cm).

The cross-sections of reinforced-concrete frame elements were $b_c \times d_c = 20.0 \times 20.0$ cm for the columns and $b_b \times d_b = 12.0 \times 20.0$ cm for the beam. The masonry infill wall was $t_i = 12.0$ cm thick with the aspect ratio $l_i/h_i = 1.4$. The opening in the masonry wall represented a window or door opening type. The window aspect ratio was $l_o/h_o = 50.0/60.0$ cm = 0.83 with the opening area $A_o = 0.30$ m², with parapet wall $P = 40.0$ cm high. The door aspect ratio was $l_o/h_o = 35.0/90.0$ cm = 0.39 with the opening area $A_o = 0.32$ m².

The frame elements were reinforced with ribbed reinforcing bars (longitudinal reinforcement $\phi 10$ mm for columns and $\phi 10$ mm and $\phi 6$ mm for beams). Stirrups in columns with $\phi 6$ mm were placed at an interval of 7.5 and 15 cm and in beams $\phi 6$ mm placed at intervals of 10 and 20 cm. Reinforcement details are shown in Fig. 1.

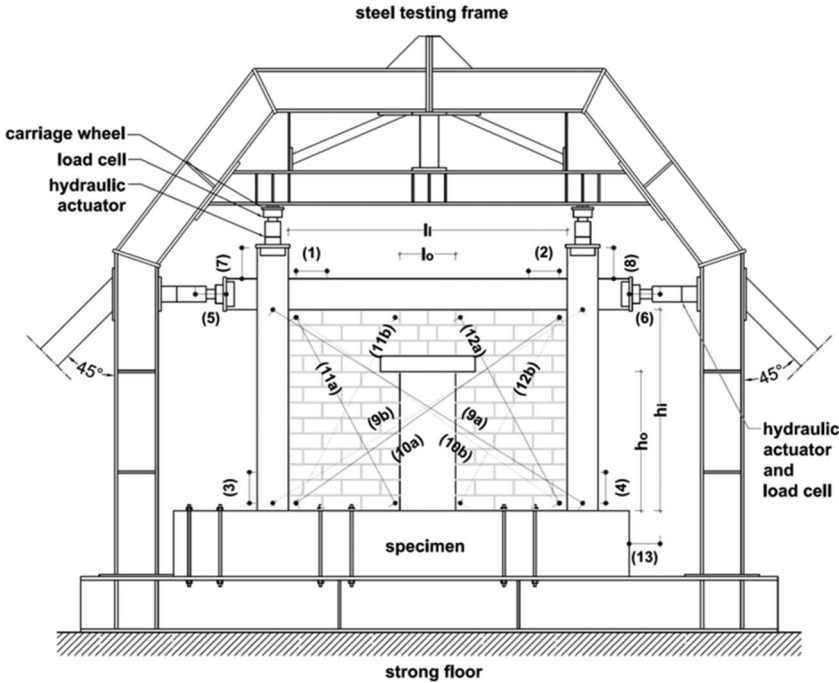
FIGURE 3 Test setup.

The test setup consisted of a closed steel testing frame connected to the strong floor. Lateral deformations of the resisting frame were prevented by braces, as shown in Fig. 3. The frame was stiff enough to prevent any interaction with the forced response of the specimen being tested.

Extensive instrumentation was utilized to monitor all aspects of the specimens' behavior. A schematic depiction of the instruments' location is shown in Fig. 3. The test measured applied forces by pressure transducers, lateral displacements on the left (5) and right end of the R-C beam (6) and vertical displacements (7 and 8) using LVDTs mounted on separate scaffolding. Diagonal deformations were measured by string transducers on the frame (9a and 9b) and on the masonry infill (10a and 10b) on the front (a) and back (b) side of the specimen. Specimens with openings were additionally provided with diagonal string transducers on one (11a and 11b) and/or other side of the opening (12a and 12b) depending on the opening's type and position. Measuring devices, 12a and 12b were not placed in the case of eccentric opening. Local strains were measured by strain gauges at the column's bottom and at the beam's hinge location (1–4). For signal conditioning, data acquisition

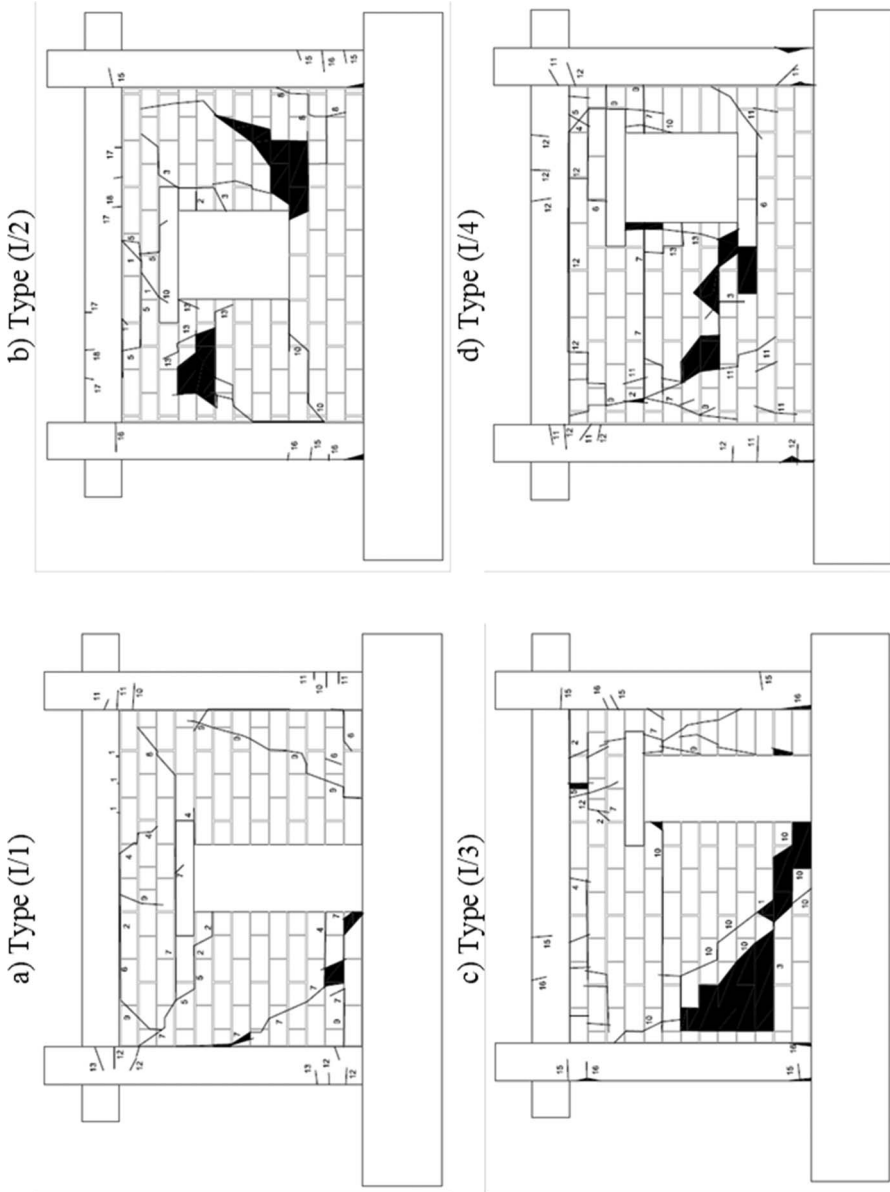
FIGURE 6 Group I specimens' crack patterns.

Diagonal tensile cracks occurred in the masonry piers at an angle of 45–65° (Figs. 6a–d). At higher drifts they became unstable and tended to fall out of the plane. Pier height was equal to that of the opening. Diagonal shear and/or horizontal bed-joint sliding shear failure of the pier were dominant.

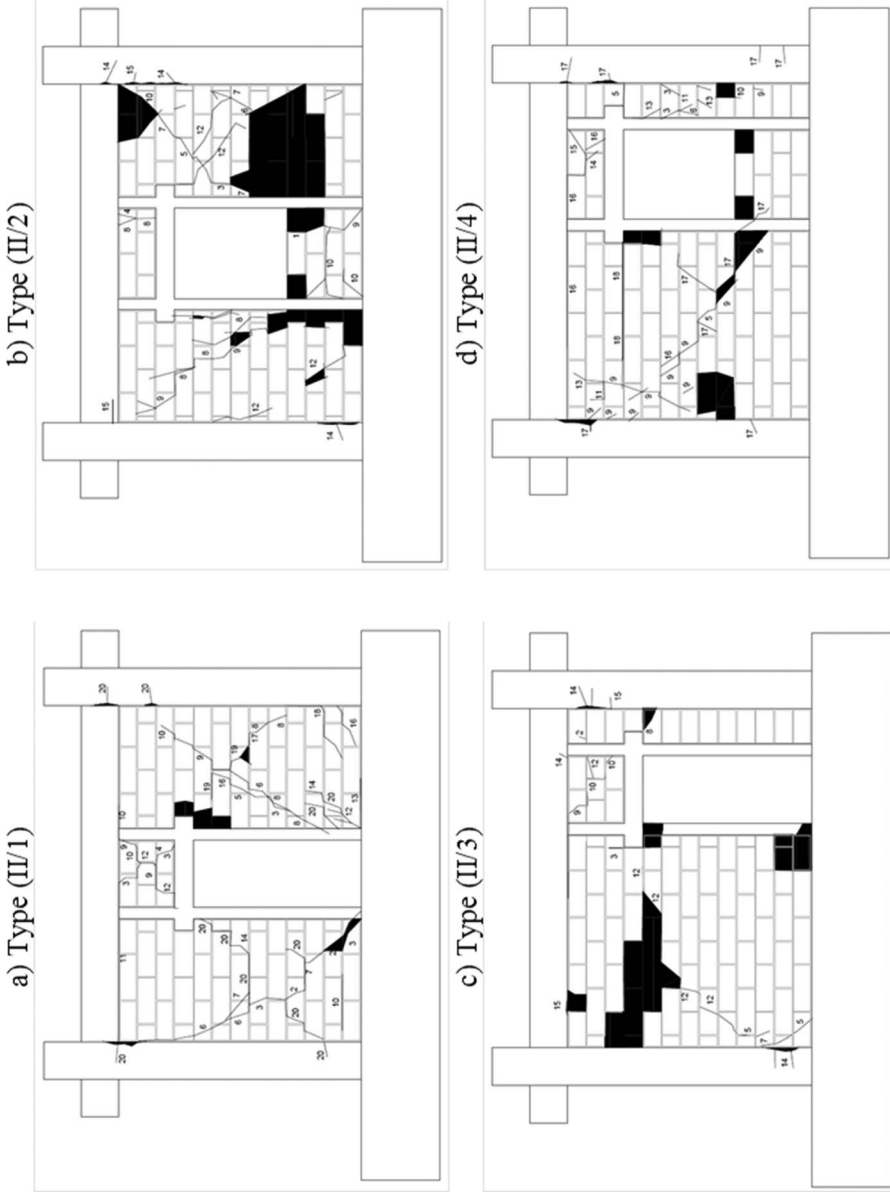
FIGURE 7 Group II specimens' crack patterns.

Introduction of the vertical tie-columns influenced the infill's behavior during the test. Diagonal tensile cracks occurred in masonry piers at an angle of 45–65° (Figs. 7a–d). The

height of the opening did not influence the pier's height and in the most cases it was equal to the infill's height (except in the case when the tie failed in shear). The cracks that crossed tie elements were observed on the specimens with eccentrically placed openings, on the side of the infill's bigger pier. They were close to the opening's edges. Dominant were diagonal shear and/or horizontal bed-joint sliding shear failures of the pier.

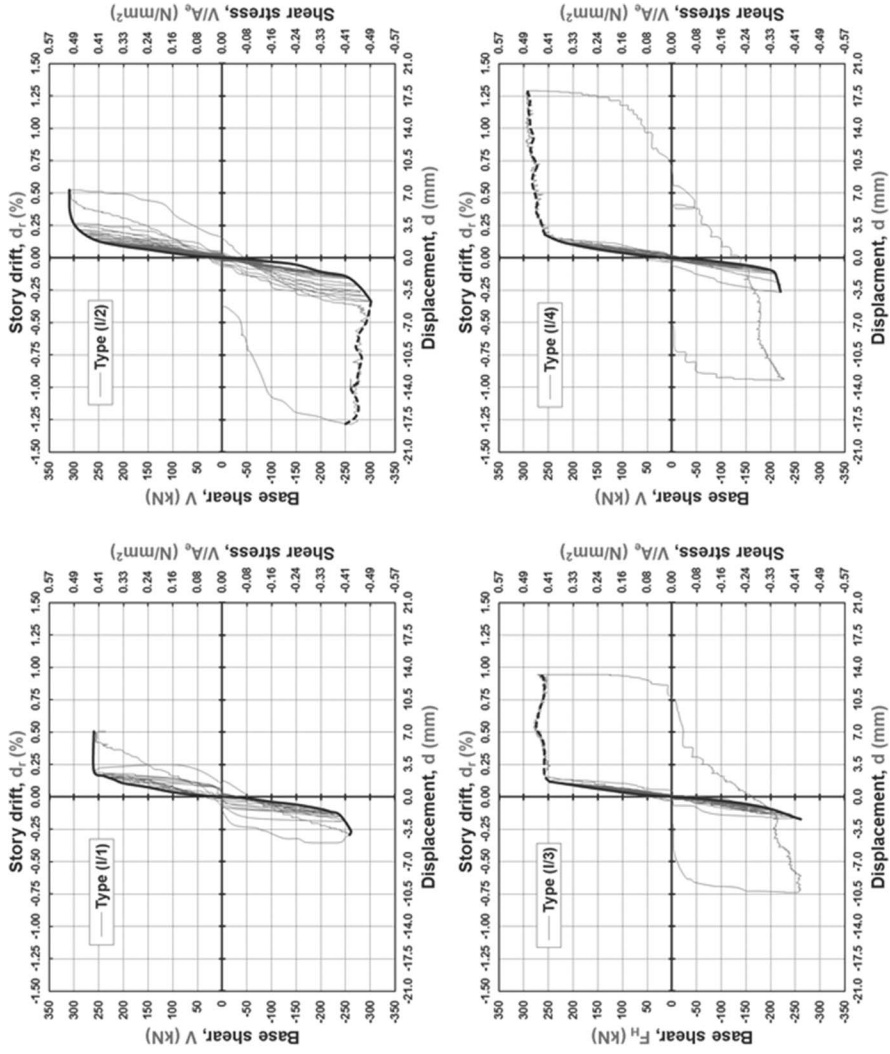
FIGURE 9 Group I specimens' hysteretic loops and resistance envelope curves.

Hysteretic loops (obtained from the second loading cycle) and the primary curves are presented in Figs. 9–11. The primary curves were obtained by connecting the peaks of these cycles (solid part) and extending further (dashed part) when the specimen was pushed from one (weak) side only (pushover). It should be noted that the difference between the

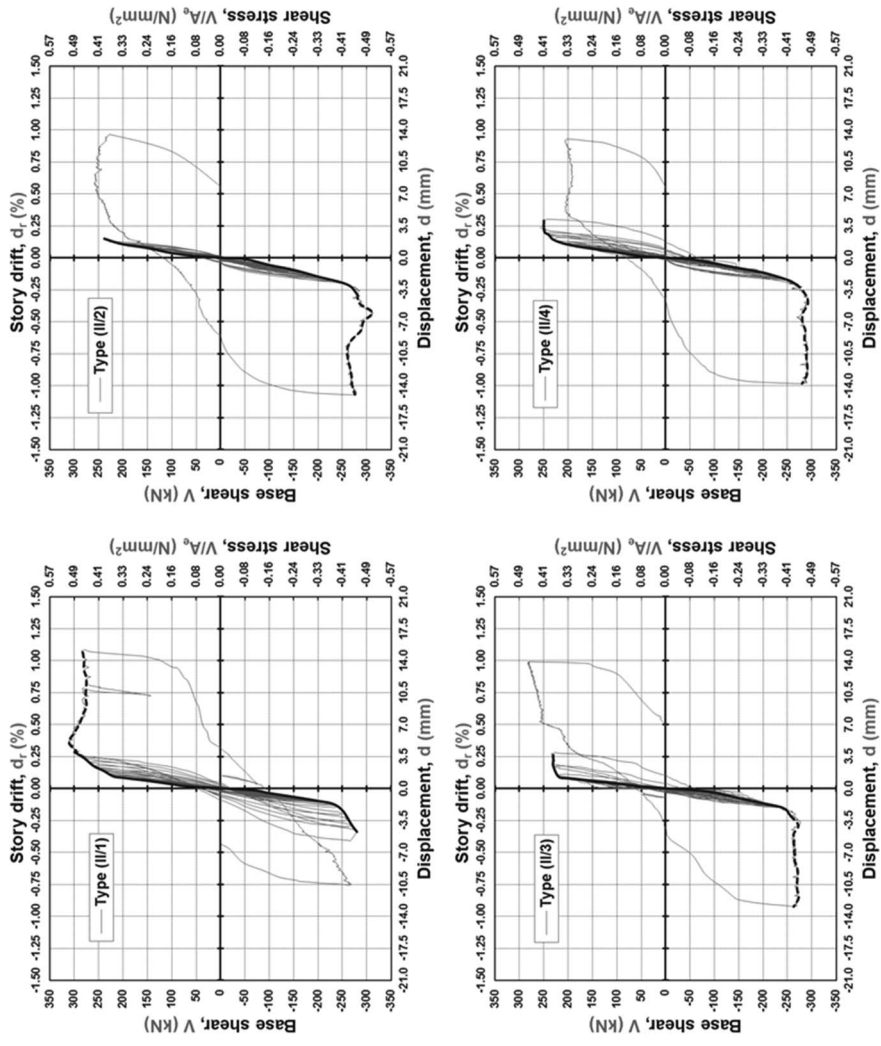
FIGURE 10 Group II specimens' hysteretic loops and resistance envelope curves.

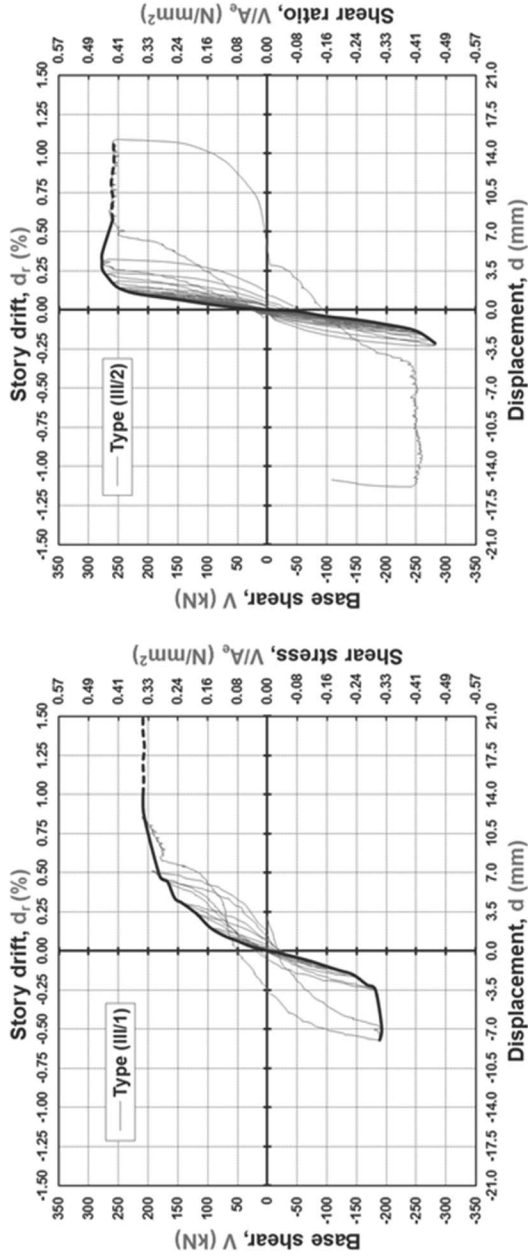
FIGURE 11 Group III specimens' hysteretic loops and resistance envelope curves.

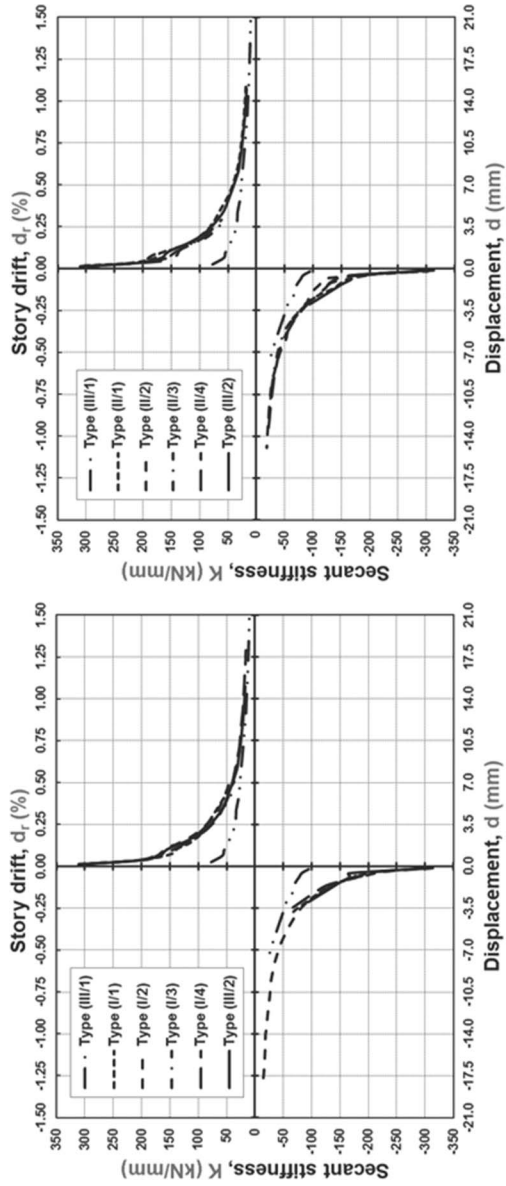
FIGURE 12 Specimen's secant stiffness degradation curves.

Measured values of the secant stiffnesses (K) for various drifts are given in Table 5. The ratios of K/K_0 , where K_0 represents the initial secant stiffness, are also presented. Degradation (changes) of the specimens' secant stiffness in respect to drift is shown in Fig. 12.

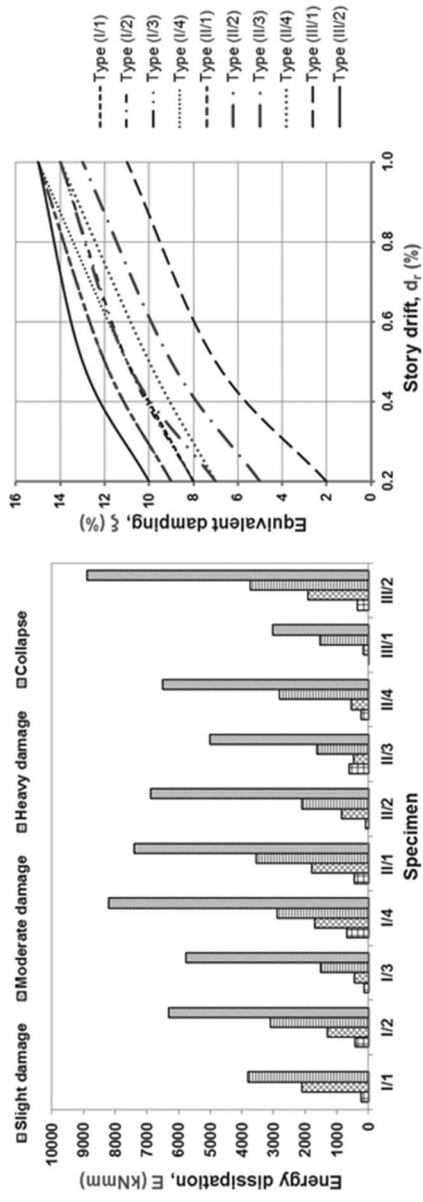
FIGURE 13 Hysteretic energy dissipated (a) and equivalent damping at different drifts (b).

Energy dissipation E (kNmm) was calculated as the sum of areas inside hysteresis loops up to a certain drift level. Calculated values and the ratio of the system's dissipated energy versus that of the bare frame (III/1) are given in Table 6 and in Fig. 13a. Dissipated hysteretic energy, at Slight and Moderate damage levels, of infilled specimens was between 5 and 20 times higher than that of the bare frame. The ratio decreased at heavy damage and collapse drifts to about twice as high.

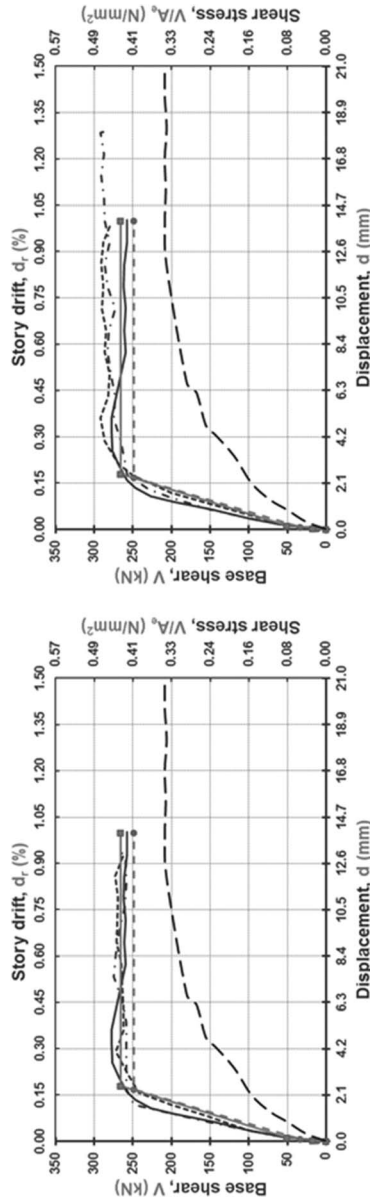
FIGURE 15 Measured and analytically estimated primary curves (weaker side).

After the ultimate resistance, the envelope extends horizontally up to drifts when the infill collapsed (1.0%). Calculated results are presented in Fig. 15 for the cases with (AWO) and without opening (AWOO), along with the measured primary curves. Differences
