# BACK TO THE FUTURE – ANDRIJA MOHOROVIČIĆ LECTURE (1909) & ZAGREB (2020) M5.5 EARTHQUAKE

**Abstract:** This review paper relates original Mohorovičić, A. lecture *DJELOVANJE POTRESA NA ZGRADE* (1909, 1911) and its English translation *EARTHQUAKE EFFECTS ON BUILDINGS* (2009) with M5.5 Zagreb 2020 earthquake damage. Mohorovičić said in Introduction of his lecture in 1909: “another strong earthquake is needed to remind people that the building techniques should be further developed and improved...”. Oliver Wendell Holmes (1809-1894) said once: “The young man knows the rules, but the old man knows the exceptions”. This should remind us that going **Back to the Future** after strong earthquake, we must go **Back to the Past**, and look after **Mohorovičić’s 15 rules how to build earthquake-resistant buildings**. He tells us how to build, and unfortunately, we were left unprepared again and didn’t listen wisdom words of an “old man”.

Review paper

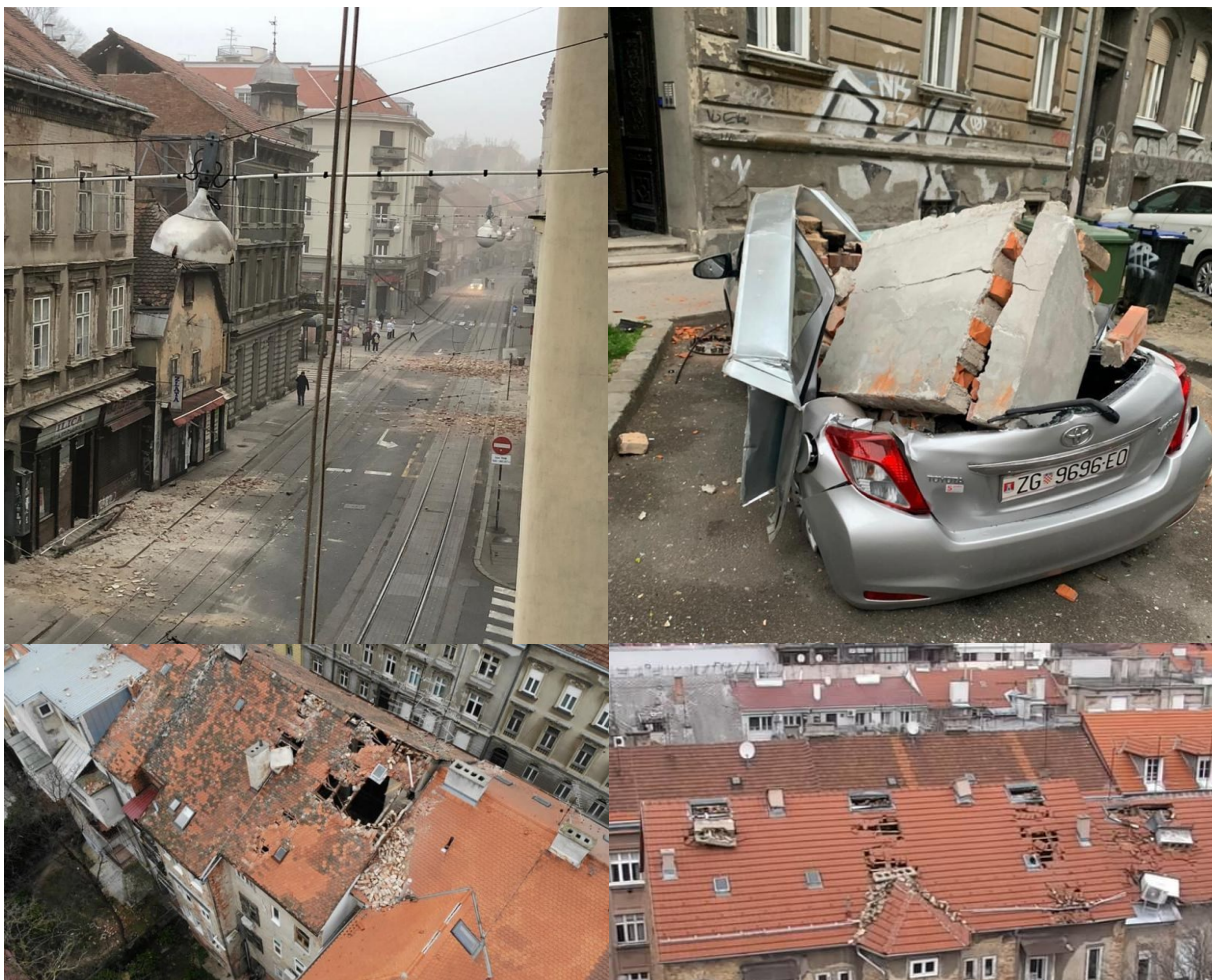
**Figure 5.** Damage in Zagreb after 22 March M5.5 earthquake. Noticeable roof tile loss and chimney collapse

14	<i>Dimnjaci neka su čim lakši i čim čvršći, čvrsto vezani s krovom.</i>	<i>The chimneys must be light and strong in the vertical direction. Where passing through the roof, they should be strongly connected with it. The height of the chimneys above the roof must not exceed 60 cm. If the higher chimneys must be built, their top must be tied to the roof on all four sides.</i>
15	<i>Da kod potresa ne pada crijep sa zgrade na ulicu, neka se na rub krova metne rešetka od željeza.</i>	<i>Iron railings should be mounted on the edges of the roof to prevent the roof tiles from falling into the street during an earthquake.</i>

With respect to **Figures 4 to 8** and Mohorovičić's 15 advices stated in **Table 1**, one can easily correlate e.g. rules 10 to 15 with building damage in **Figure 5** or rules 6 to 9 with building damage in **Figure 8**. **The cultural heritage buildings as those in Figures 4, 6 and 7, are very sensitive and require multidisciplinary approach.** The obstacles in effective implementation of the earthquake risk reduction rules (such as those stated in **Table 1**) arise when dealing with existing built environment. The detail and degree to which building's seismic performance could be improved for expected future events, meets the technical and non-technical obstacles. The latter is related unwillingness and/or inability due to lack of initiative, lack of finances or in general the lack of proper understanding of earthquake and its consequences. The technical part i.e. knowledge on building construction

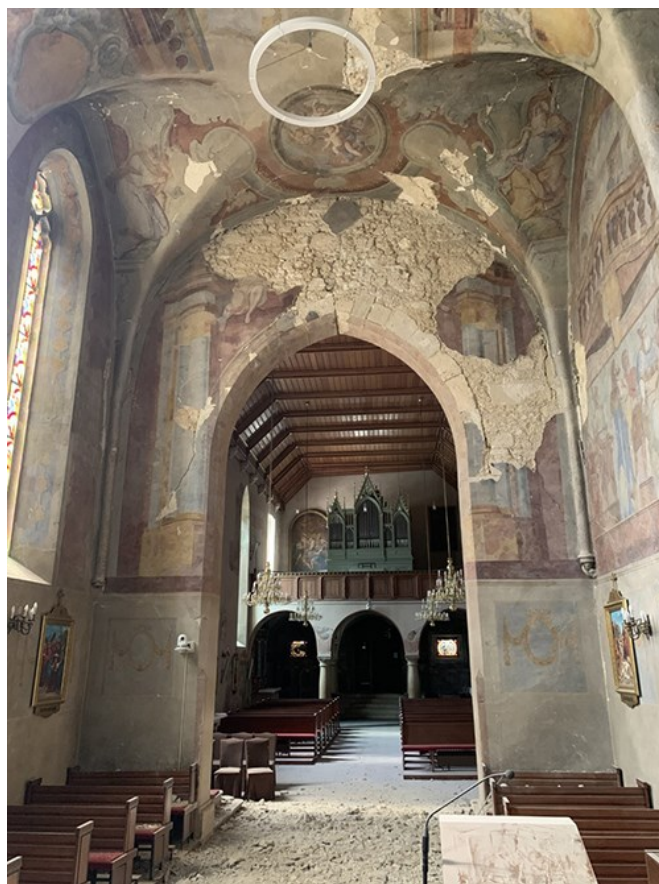
The problem of building performance, as observed in **Figures 4 to 8**, lies partially in inadequate design with respect to corresponding seismic demand, and in other part in lack of implementation, or lack in general, of available research solutions for their protection (e.g. the heritage building Shrine of Saint Mary of Remete dating from 1786 shown in **Figure 7** was already once severely damaged in 1880 Zagreb earthquake). For the seismic safety purposes, it is therefore required to adopt and enforce the seismic rules and regulations (e.g. see **Table 1**), with particular attention to cultural heritage sites.

**Figure 7.** Damage to cultural heritage: Shrine of Saint Mary of Remete from 1786  
<https://www.24sata.hr/news/pogledajte-trenutak-potresa-u-crkvi-u-remetama-u-zagrebu-682565>

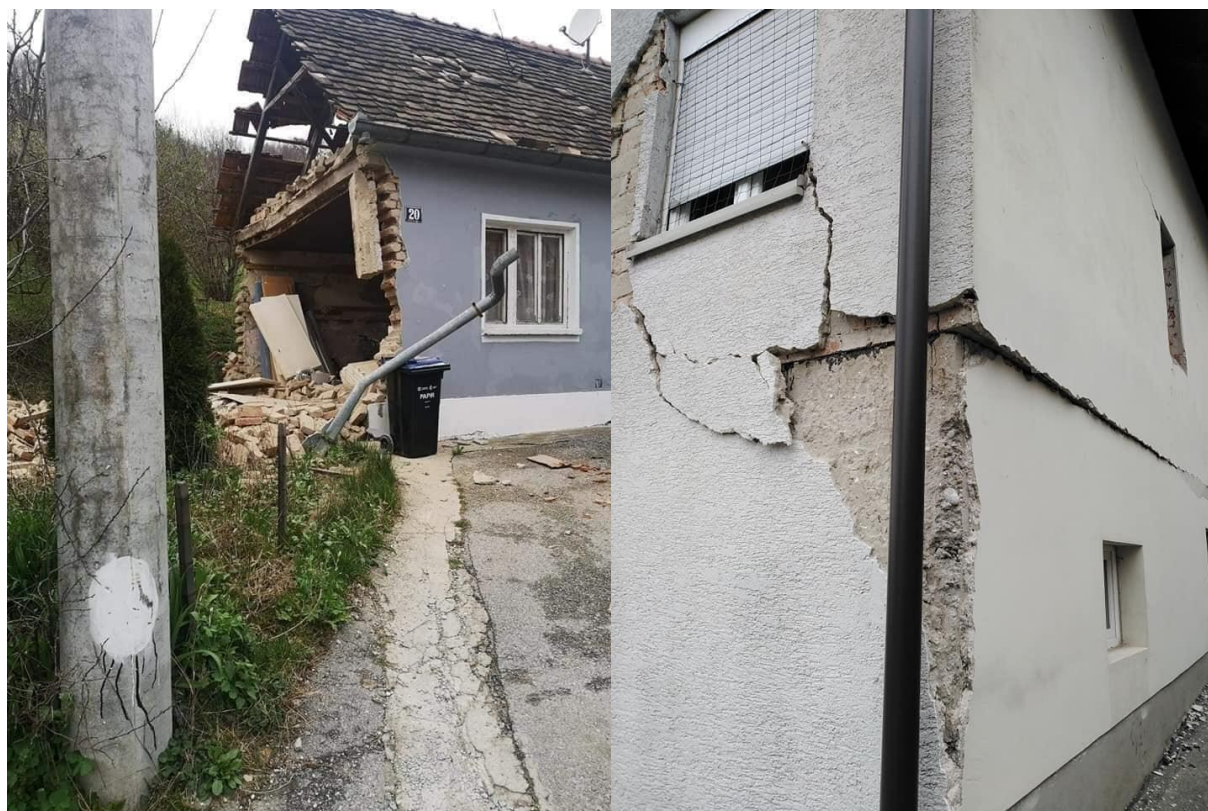
**Figure 8.** Heavily damaged family house near the epicenter.  
<https://dnevnik.hr/vijesti/hrvatska/potres-u-zagrebu-ostali-bez-domova---598777.html>
