Source / Izvornik: **Tehnički vjesnik, 2010, 17, 209 - 215**

TESTING OF PHYSICAL AND MECHANICAL PROPERTIES OF BRICKS AND MORTAR IN HISTORIC STRUCTURES

Mirjana Bošnjak-Klečina, Silva Lozančić

Preliminary notes

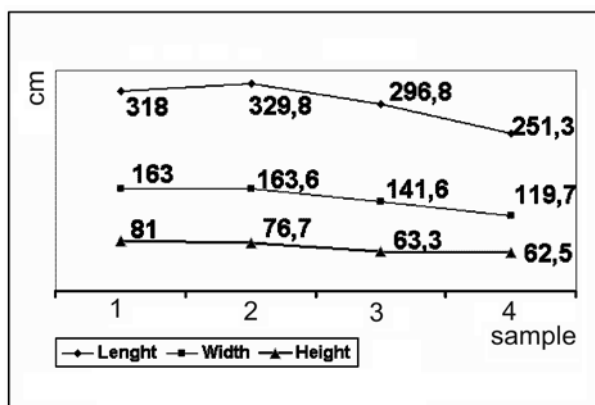
Figure 6 Bricks' dimensions, the mean values
Slika 6. Dimenzije opeka, srednje vrijednosti

The bricks' dimensions. The old brick of the smallest size under present research comes from the Eltz's manor house in Vukovar. Its dimensions (the mean value) compared to nowadays size are 18 % longer and wider, and 2 % taller.

The biggest deviations from the mean value for one sample of old brick are within 6 %. The biggest deviations from the mean value for new brick samples are within 1 %. Fig. 6 indicates the mean value of the brick's dimensions for each tested sample.

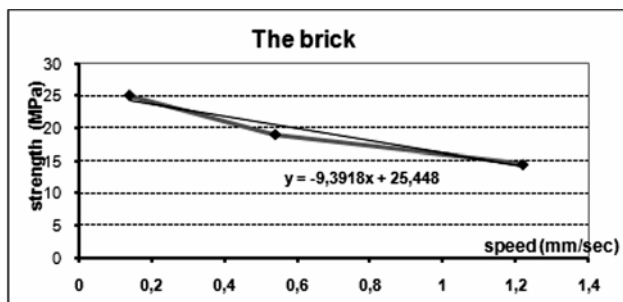
Figure 15 Relationship between the brick compressive strength and penetration speed
Slika 15. Veza čvrstoće opeke i brzine prodiranja svrdla

If we present the penetration speed for one load and correlate it to a brick strength obtained by destructive tests then we have a situation as shown in Fig. 15 that indicates the relationship between the brick compressive strength and penetration speed under constant force and drill rotation speed for three brick samples of different strengths. It is obvious that the penetration speed is almost linear with the material strength, i.e. the drill penetrates faster into weaker material.
