Source / Izvornik: **Tehnički vjesnik, 2010, 17, 209 - 215**

TESTING OF PHYSICAL AND MECHANICAL PROPERTIES OF BRICKS AND MORTAR IN HISTORIC STRUCTURES

Mirjana Bošnjak-Klečina, Silva Lozančić

Preliminary notes

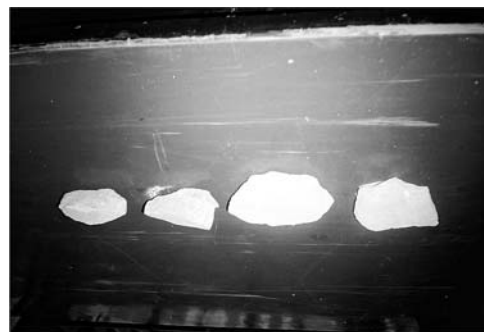
The old mortar samples were taken from the 18th century structure located at the Tvrdja in Osijek, built at the same time and with the same material as the observed structures. Because of the difficulties connected with finding the right undisturbed samples the scope of investigation has been limited. The samples were obtained by removing the mortar from the existing building.

Figure 4 The samples removed from the building
Slika 4. Uzorci izvađeni iz građevine

Figure 5 Samples prepared for testing
Slika 5. Uzorci pripremljeni za ispitivanje

The samples are presented in Figures 4 and 5.
